Home Inspection Report

Kuna, ID 83634

Inspected On Tue, Oct 4, 2022 at 1:00 PM

Upright Home Inspection
(208) 241-9059
UprightInspections.com

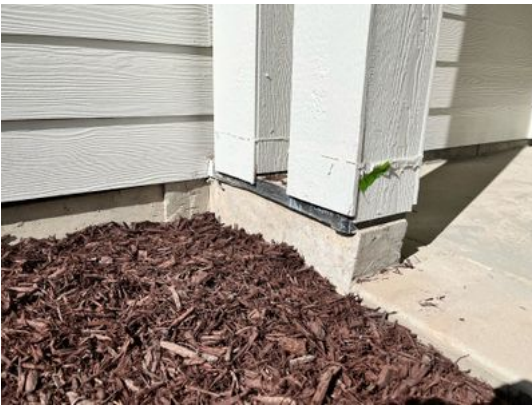
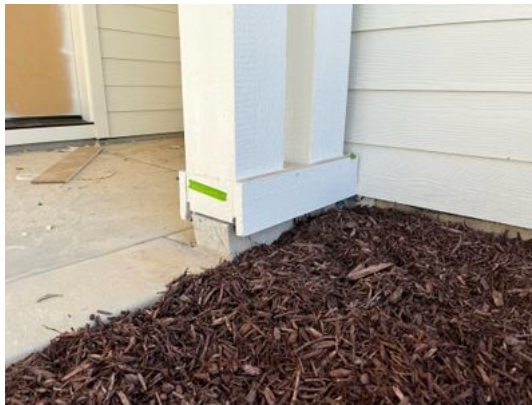
Trim finishing, sealing joints and painting recommended throughout exterior and including posts at entrance stoop.

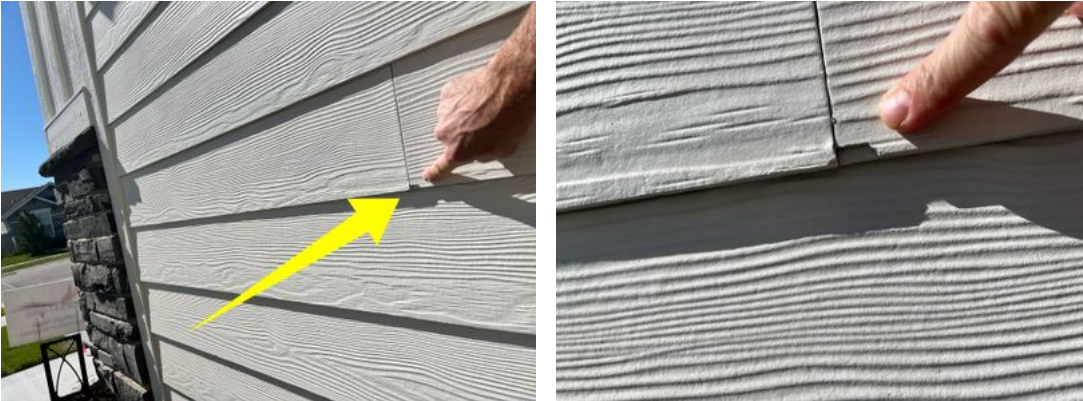
Many areas taped to identify their need to sealed and prepped for final weatherproof painting.

One board near entrance observed to have a chip in it. Replacement recommended.

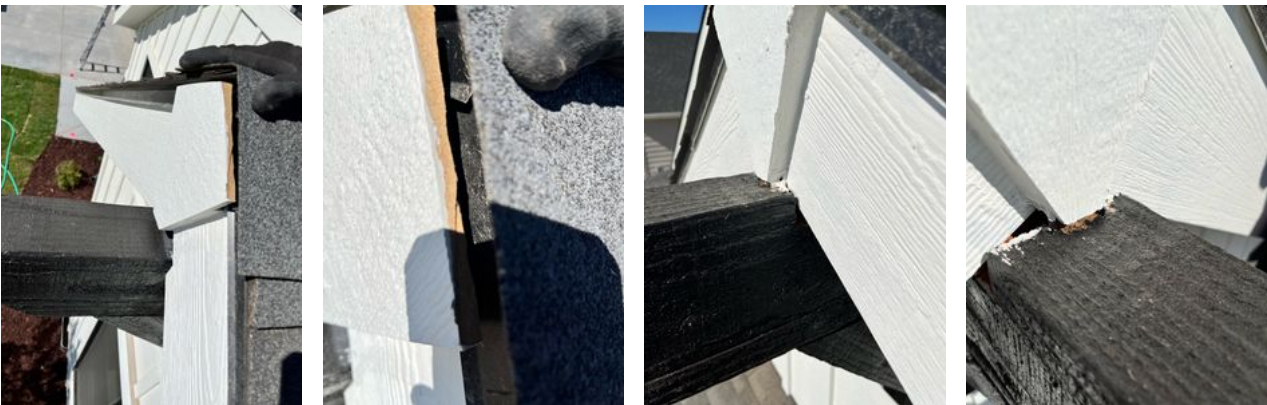
It is recommended to seal sawn wood to prevent rapid deterioration from moisture at these identified trim pieces.

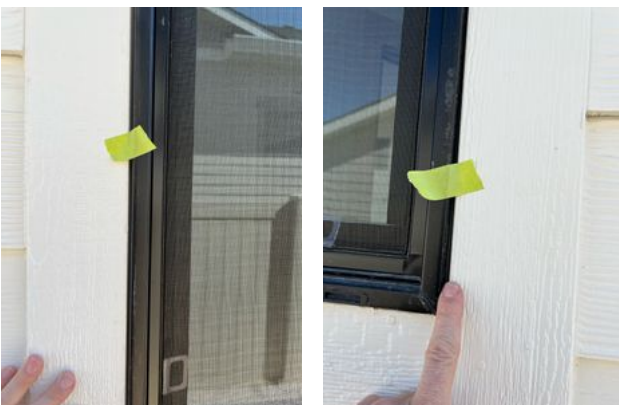
Window trim had gaps that should be filled with an appropriate sealant. Windows sills in the home exhibited moderate damage that appeared to be from moisture intrusion. Sealant around the window exteriors should be re-applied as necessary to avoid continuing damage. All work should be performed by a qualified contractor.

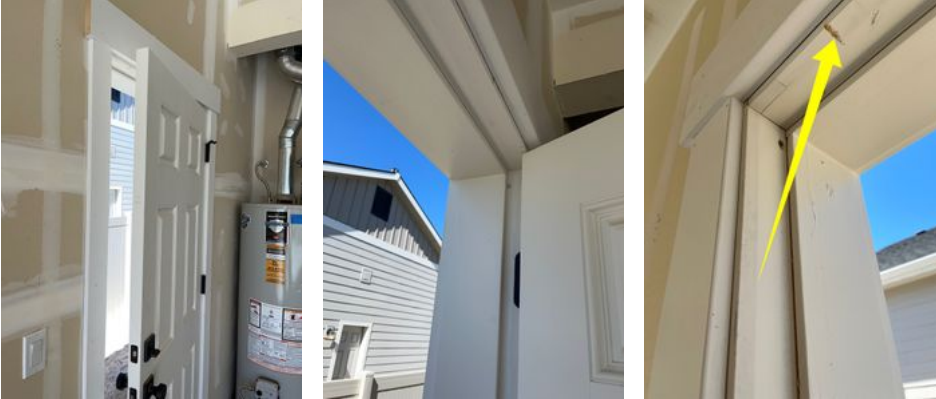
Conventional garage entry door missing weatherstripping. Damage to frame observed. Repairs recommended by qualified contractor.

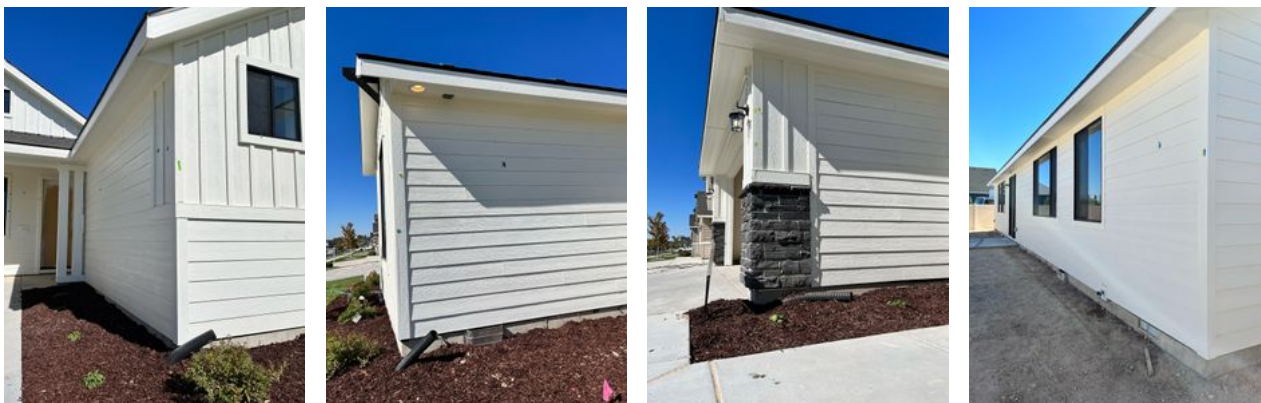
Gutters were not installed at the time of inspection. A gutter system is recommended. The Inspector recommends the installation of downspout extensions to discharge roof drainage a minimum of 6 feet from the foundation.

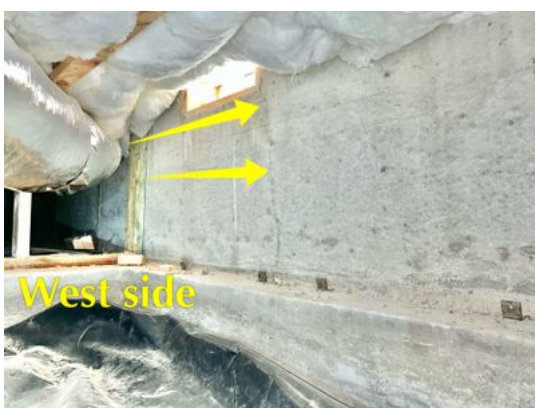
Cracking visible at the foundation wall appeared typical of differential settlement. Differential settlement happens when one portion of the foundation settles at a rate different from adjacent portions of the foundation. Stresses are created at the point of changing support that are relieved by cracking. Settlement typically takes place in the first few years after original construction, and then stops. Cracks exceeding 1/16-inch in width should be filled with an appropriate material to prevent future damage from freezing moisture and monitored in the future for continued activity. A qualified foundation contractor is recommended to evaluate and seal these cracks.

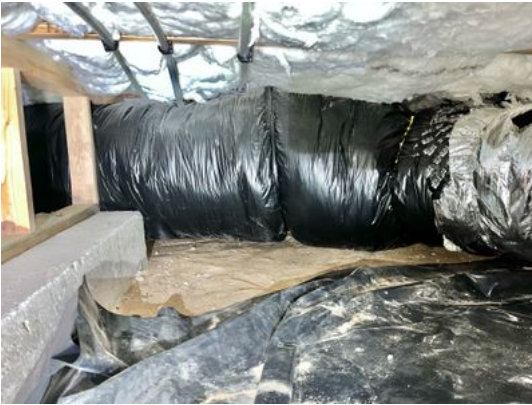
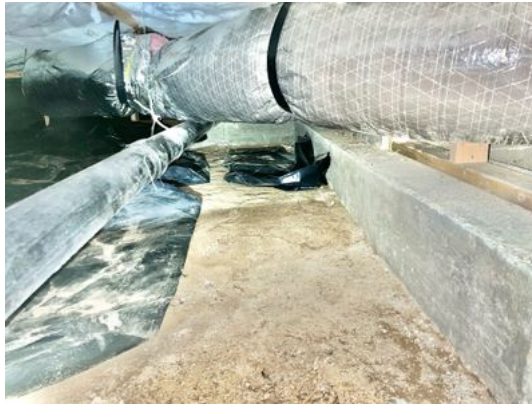
The floor of the crawlspace was covered with a vapor barrier cover that consisted of sheet plastic. Soil covers are installed to help minimize moisture evaporation into crawlspace air from the soil. Edges at overlaps and the crawlspace perimeter were not sealed. It is recommended to repair this condition and replace barrier as needed.

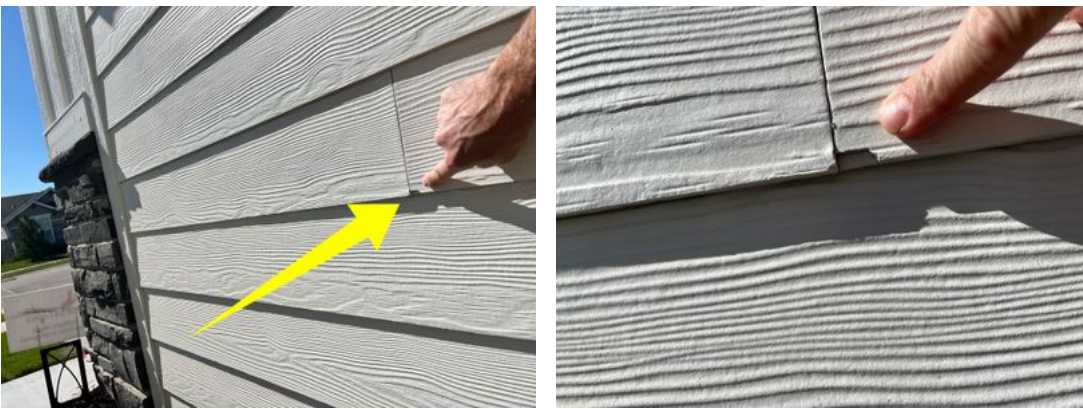
Comment 2

Many areas taped to identify their need to be sealed and prepped for final weatherproof painting.

One board near entrance observed to have a chip in it. Replacement recommended.

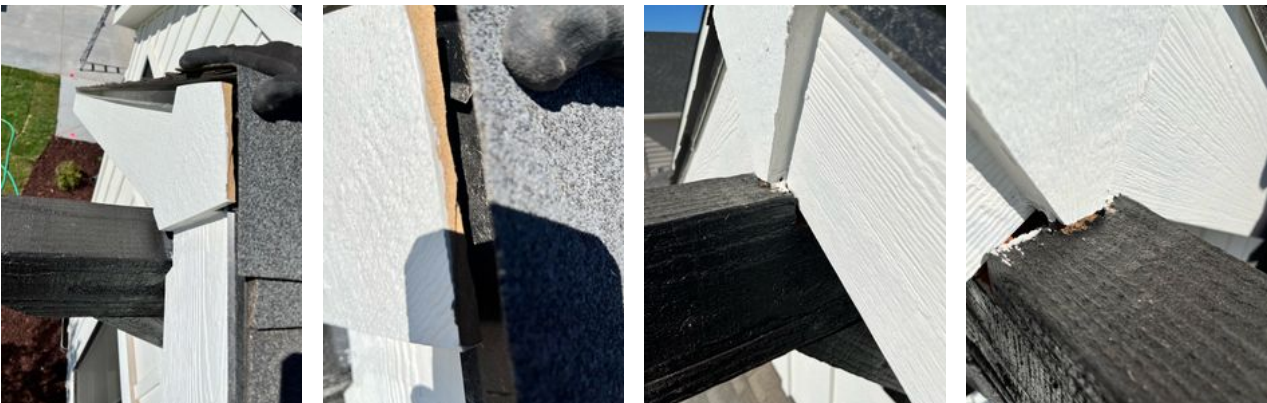
Comment 3

It is recommended to seal sawn wood to prevent rapid deterioration from moisture at these identified trim pieces.

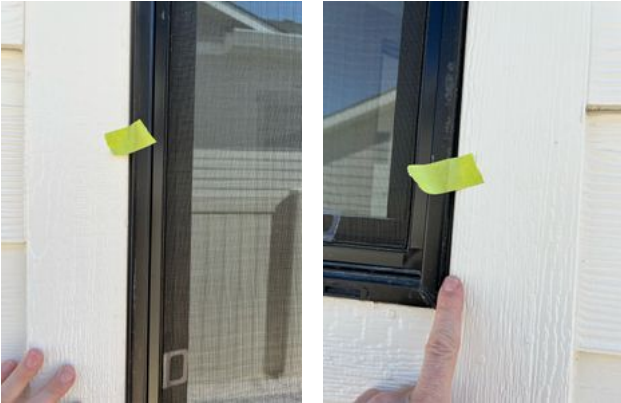
Comment 4
Deficiency

Window trim had gaps that should be filled with an appropriate sealant. Windows sills in the home exhibited moderate damage that appeared to be from moisture intrusion. Sealant around the window exteriors should be re-applied as necessary to avoid continuing damage. All work should be performed by a qualified contractor.

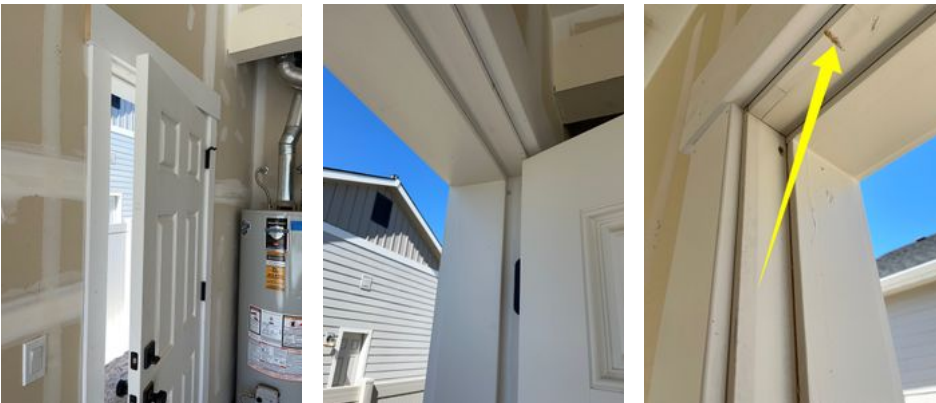
Comment 5
Deficiency

Conventional garage entry door missing weatherstripping. Damage to frame observed. Repairs recommended by qualified contractor.

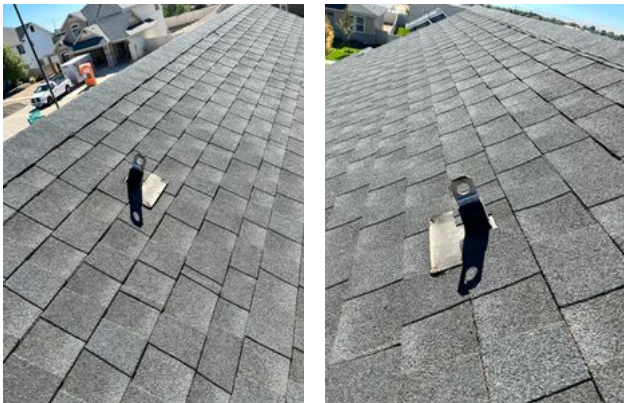
**Comment 8
Information**

Two fall protection anchors were not covered at time of inspection. Replacing the plastic covers is recommended.

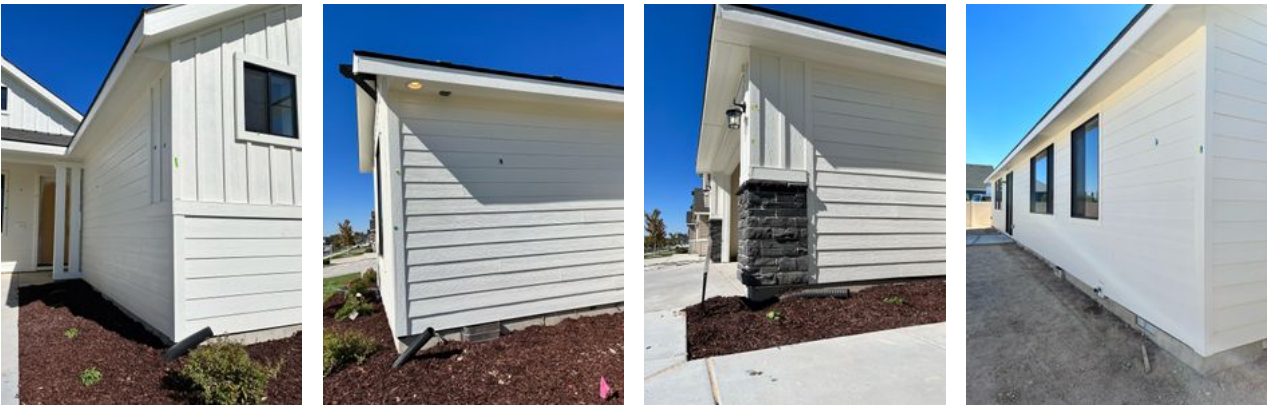
Comment 9

Gutters were not installed at the time of inspection. A gutter system is recommended. The Inspector recommends the installation of downspout extensions to discharge roof drainage a minimum of 6 feet from the foundation.

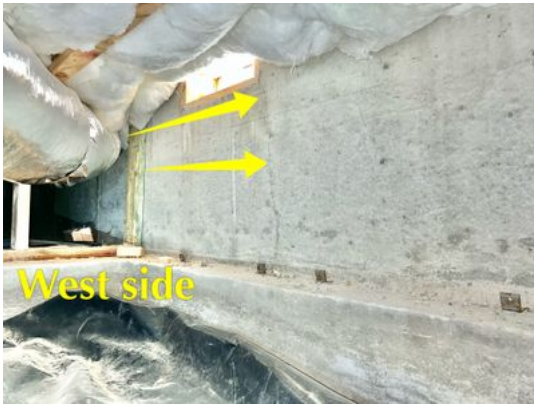
Comment 11 Deficiency

Cracking visible at the foundation wall appeared typical of differential settlement. Differential settlement happens when one portion of the foundation settles at a rate different from adjacent portions of the foundation. Stresses are

created at the point of changing support that are relieved by cracking. Settlement typically takes place in the first few years after original construction, and then stops. Cracks exceeding 1/16-inch in width should be filled with an appropriate material to prevent future damage from freezing moisture and monitored in the future for continued activity. A qualified foundation contractor is recommended to evaluate and seal these cracks.

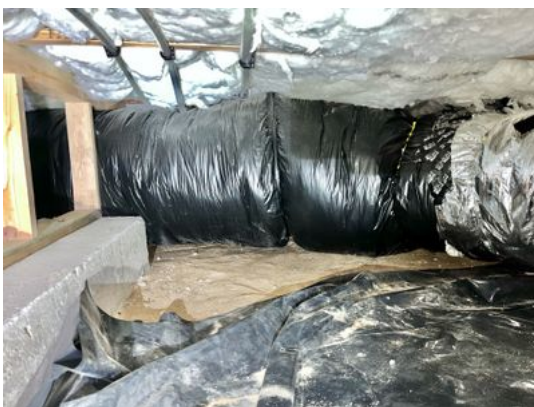
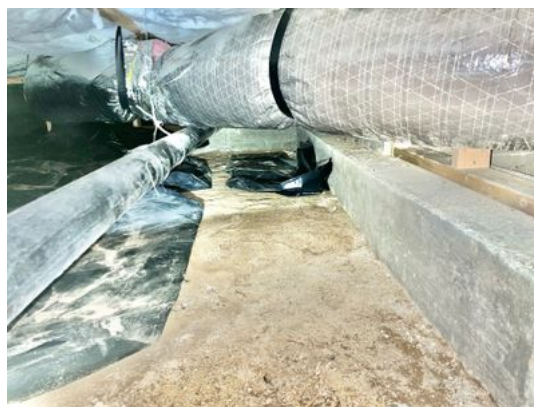
Comment 13
Deficiency

The floor of the crawlspace was covered with a vapor barrier cover that consisted of sheet plastic. Soil covers are installed to help minimize moisture evaporation into crawlspace air from the soil. Edges at overlaps and the crawlspace perimeter were not sealed. It is recommended to repair this condition and replace barrier as needed.

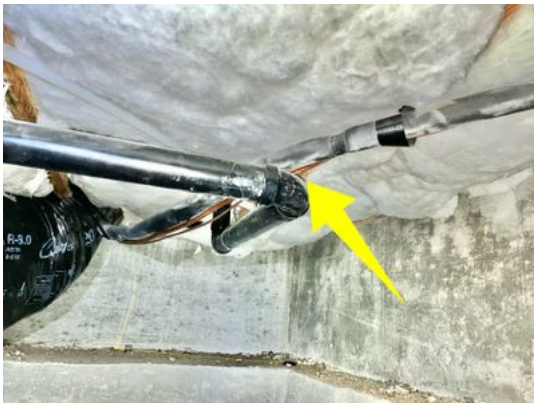
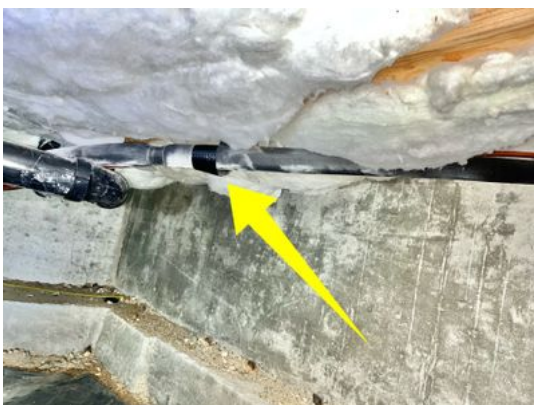
Comment 15

The A/C line set was resting upon a waste or drain pipe at the time of inspection. This condition may damage the pipe or loosen the connections. The inspector recommends correction by a qualified plumbing contractor.
