Home Inspection Report

123 Fakesbille

Inspected By: Scott Frasure

Inspected On Thu, Oct 3, 2024 at 9:00 AM

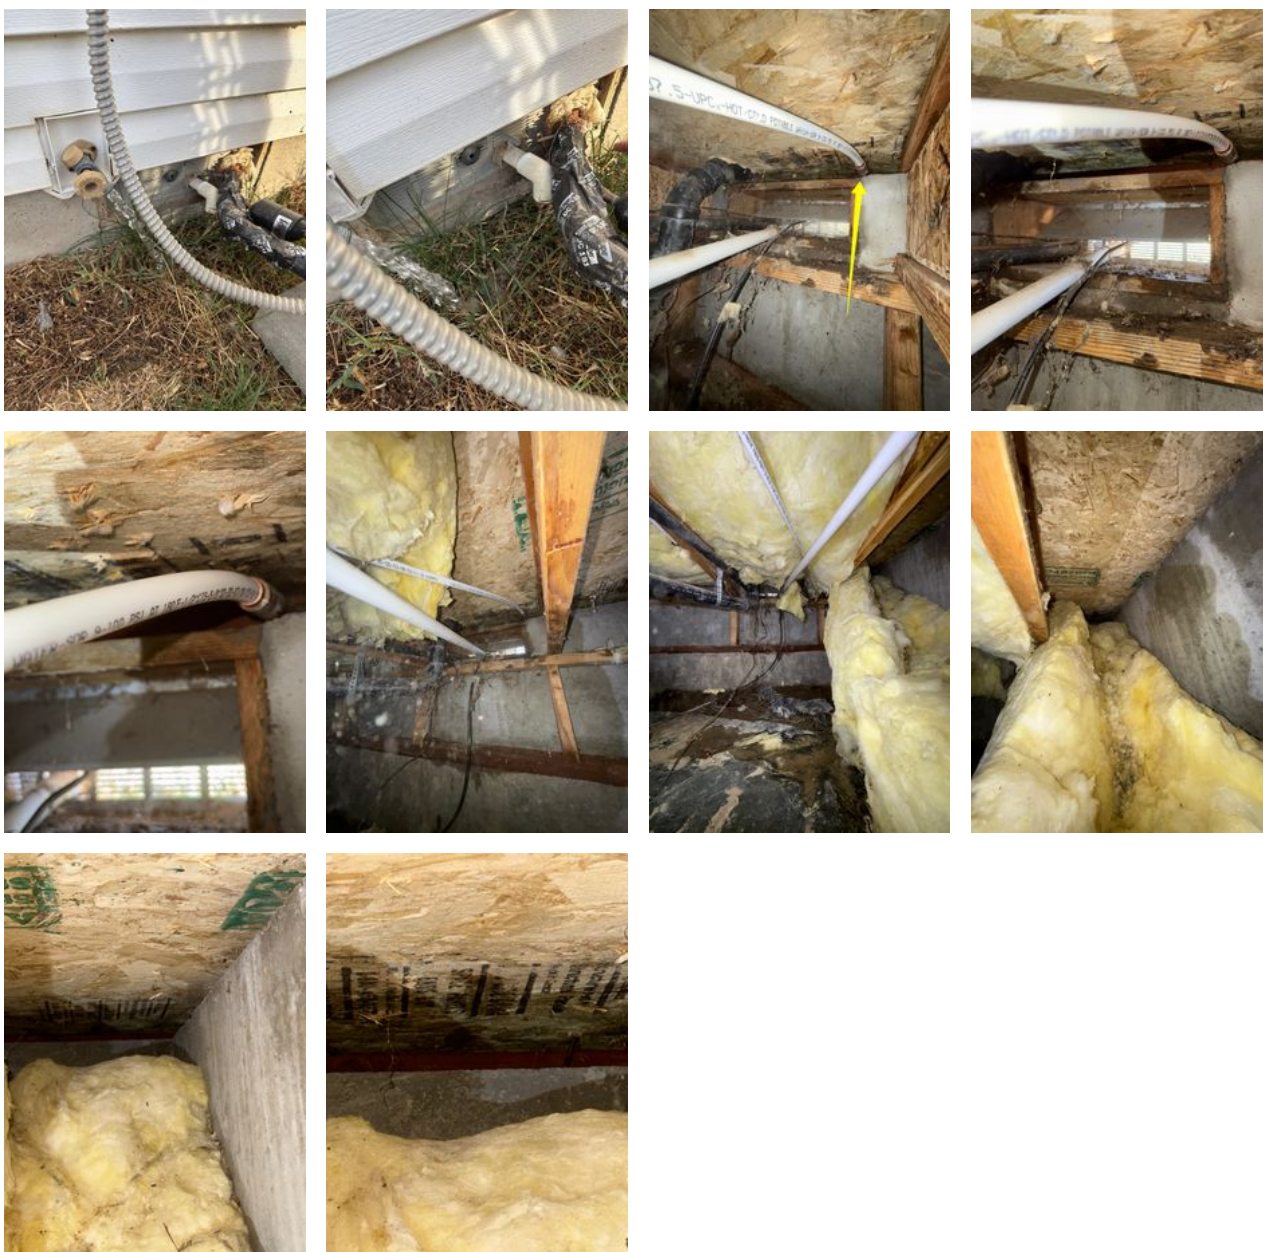
When the hose bibb near the rear door was operated, the water dispensed as intended and was leaking out of the adjacent crawl space vent. The valve was immediately turned off to prevent further water damage. Upon inspecting the crawl space, the leak was confirmed with moisture on the vapor barrier, the insulation and the adjacent building material. This appears to be a relatively recent developed condition. Repairing this water line is required before using this hose bibb and it is recommended to ensure all necessary materials are in acceptable condition prior to closing.

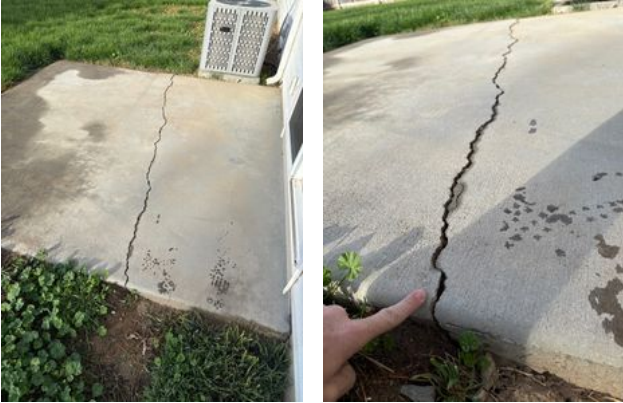
Site: Patios/Decks

The patio surface had moderate cracking visible. Cracks wider than 1/4-inch should be filled with an appropriate material to help prevent continued deterioration from freezing moisture.

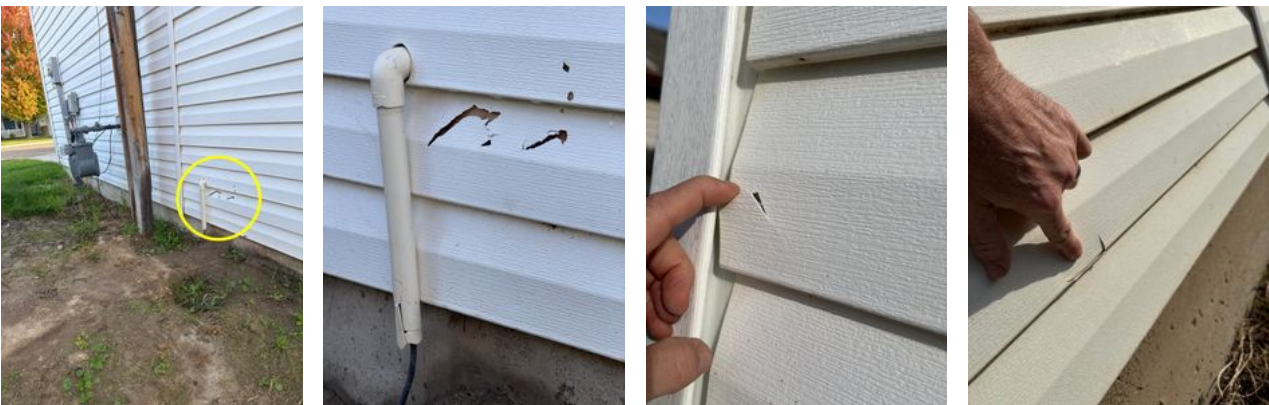
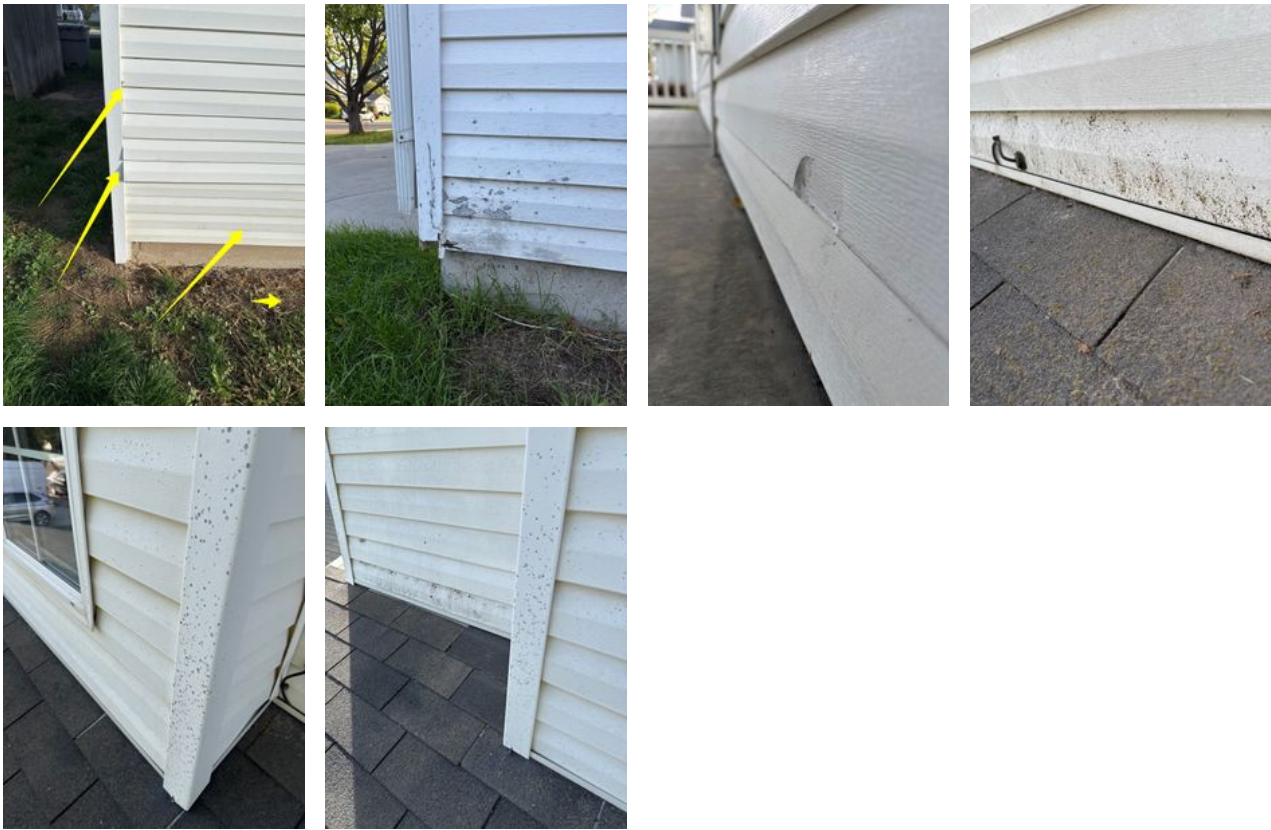
Exterior: Exterior Covering

Some areas of the vinyl siding was observed to have cracking damage. Replacement of these damaged areas is preferred to prevent moisture from penetrating the wall sheathing. Many damaged areas were observed to be repaired. Regular maintenance of these repairs is recommended.

Staining on vinyl siding above the front porch is suspected from the past overgrowth of adjacent tree. It is recommended a qualified contractor make the siding repairs and remove the organic material from the siding at the front of the house.

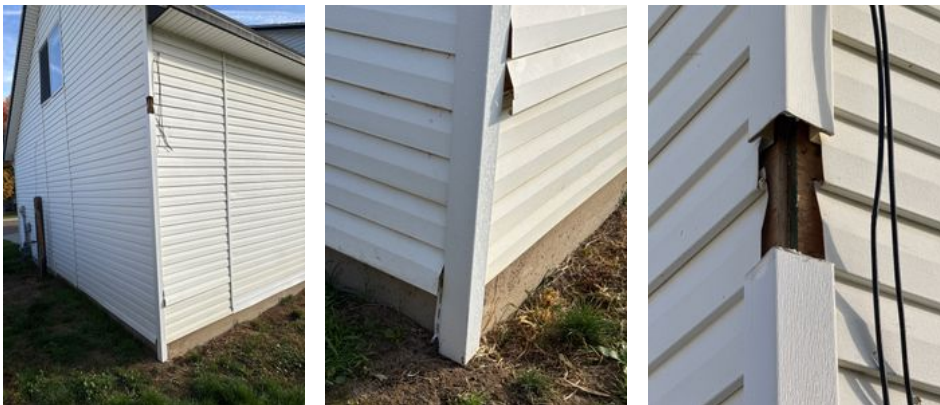
Exterior: Exterior Trim Material

This vinyl trim piece has disconnected from the attachment point and has exposed the exterior sheathing. Replacement of this trim piece is required to protect the homes building material from damage.

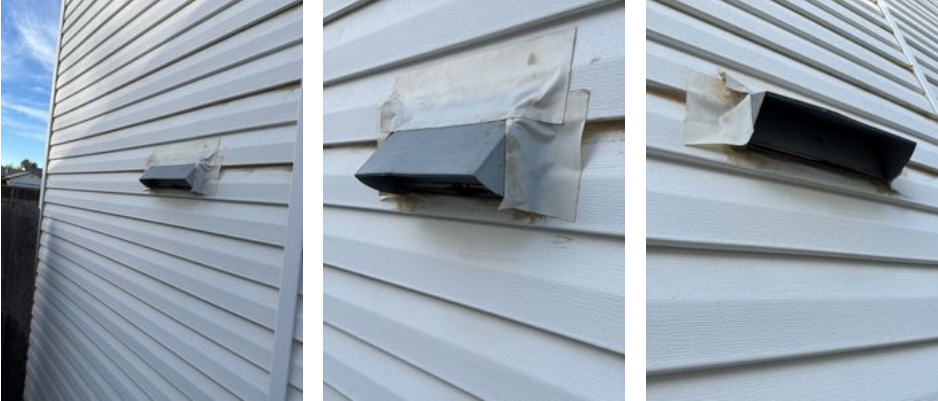
Exterior: Exterior Trim Material

The appropriate trim was not installed around this exhaust vent discharge. All exterior wall penetrations require the appropriate flashing and trim pieces to prevent moisture intrusion. Replacement is recommended.

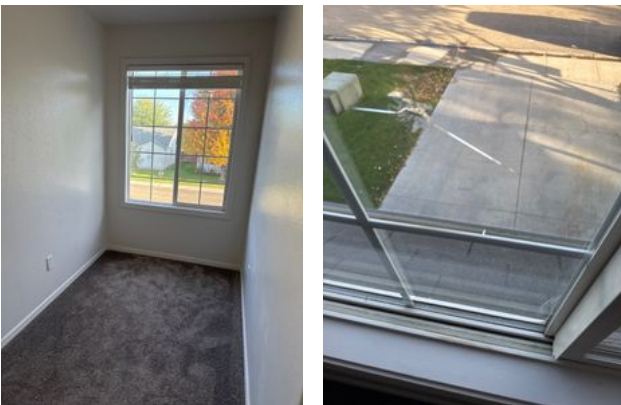
Exterior: Windows

A window on the north side of the home in the bonus room was observed to have a broken pane. Replacing this window is recommended.

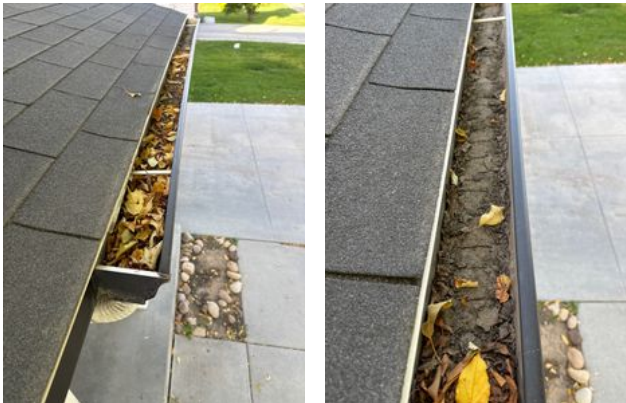
Roofing: Gutters & Downspouts

This gutter over the front entryway was filled with sediment, indicating a lack of proper gutter drainage. Repairing this condition will help shed the water from the roof and away from the foundation.

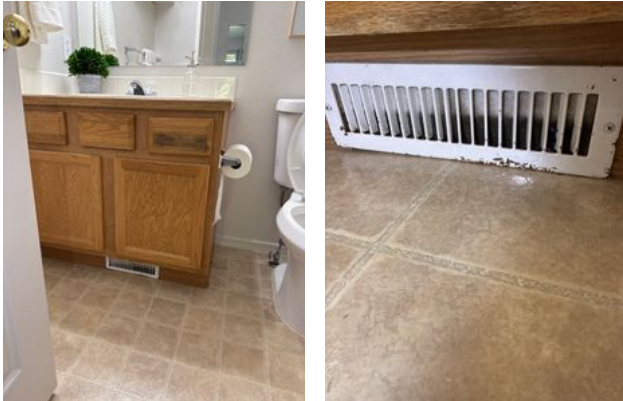
HVAC: Heating: Type of Distribution

The register in this upstairs full bathroom was blocked at the time of inspection. Repairing this condition is recommended to help regulate the temperature in this bathroom.

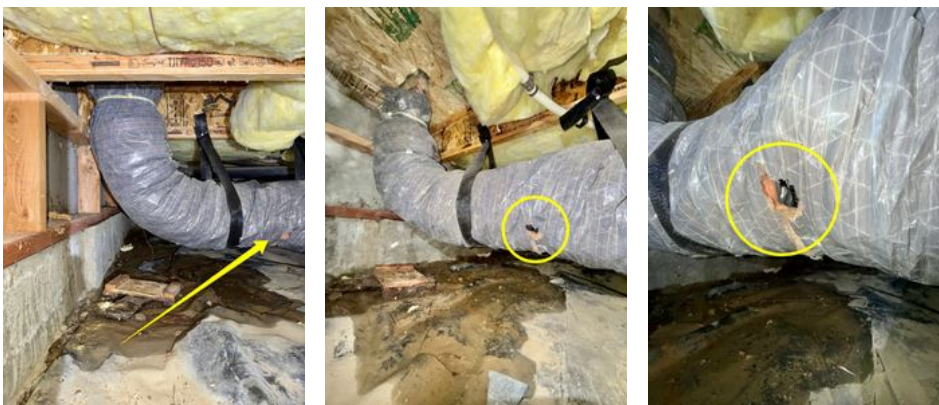
HVAC: Heating: Type of Distribution

A flexible supply duct in the crawlspace appeared to have damage from mice. This will dispense the conditioned air into the crawlspace. It is recommended to acquire an estimate from a qualified HVAC contractor for replacement.

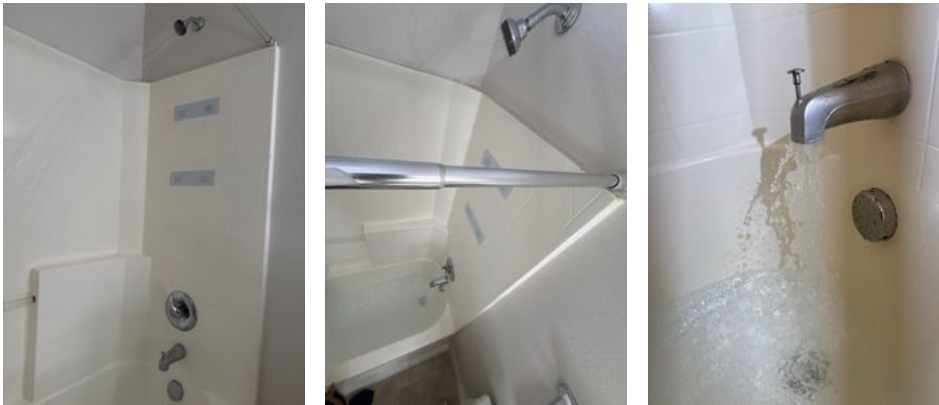
Bathrooms: Bathroom #1: Shower

The diverter valve did not operate correctly (the diverter is the valve that diverts water from the tub faucet to the shower head). Water was diverted to shower head but continued to flow from tub faucet. The Inspector recommends maintenance be performed by a qualified contractor.

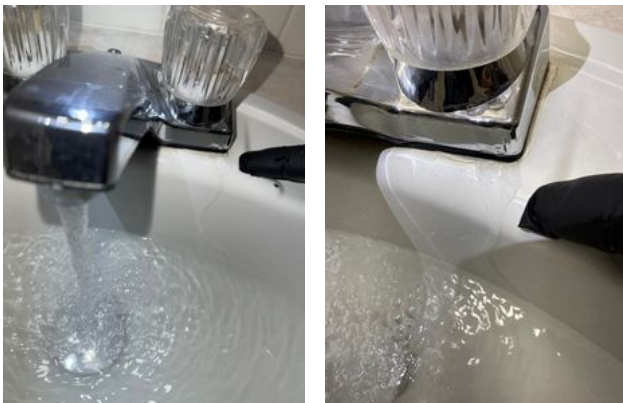
Bathrooms: Bathroom #2: Sink(s)

Water was flowing out of the handle on the cold water side in this sink faucet. Repairing this is or replacing faucet is recommended.

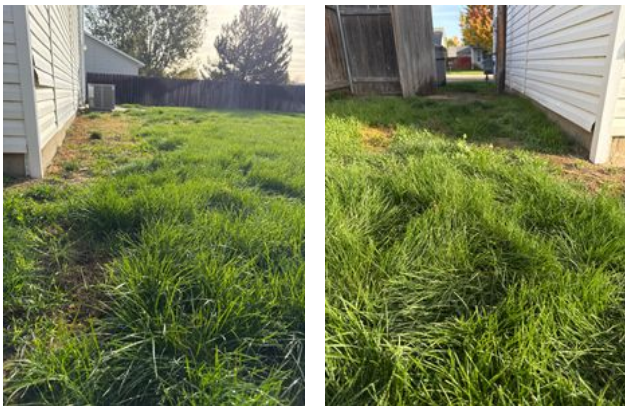
Site: Site Grading

It is recommended to ensure that the grade slopes away from the home. The home had areas of neutral or negative drainage that will route runoff from precipitation toward the foundation. The ground should slope away from the home a minimum of 1/4-inch per foot for a distance of at least six feet from the foundation.

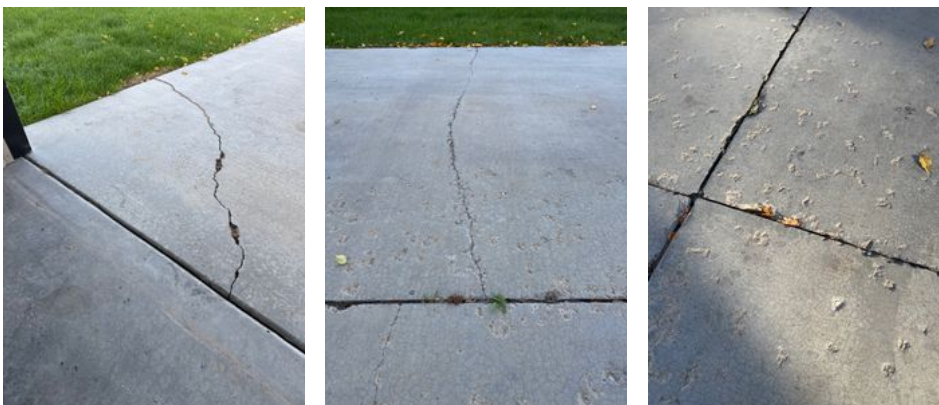
Site: Driveway

The driveway had areas of pop-out visible. Pop-outs are typically caused by aggregate (stones or gravel) in the concrete that react to moisture by expanding slightly, causing the concrete directly above to detach from the surface. This condition is primarily cosmetic, although in some cases it can lead to further slow deterioration if surface moisture comes into contact with embedded reinforcement steel.

Common cracks were visible in the driveway. Cracks exceeding 1/4 inch should be filled with an appropriate material to avoid continued damage to the driveway surface from freezing moisture.

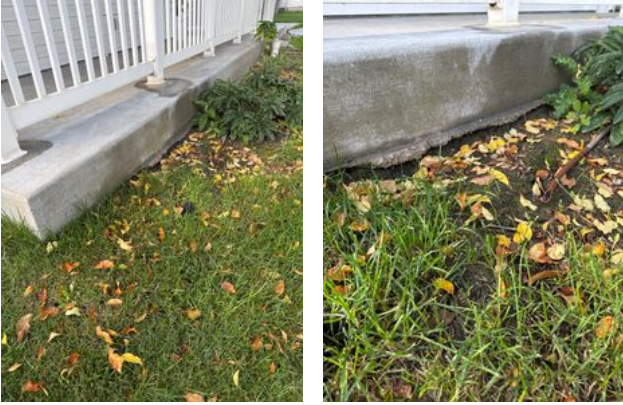
Site: Steps/Stoops

It is recommended to add backfill to support this section of the porch. Backfill is the process of filling in gaps or areas where soil has eroded or settled. By adding backfill, you can improve the stability of the porch, prevent further erosion, and ensure that it remains level and safe for use. This will help protect the porch from potential damage caused by shifting soil.

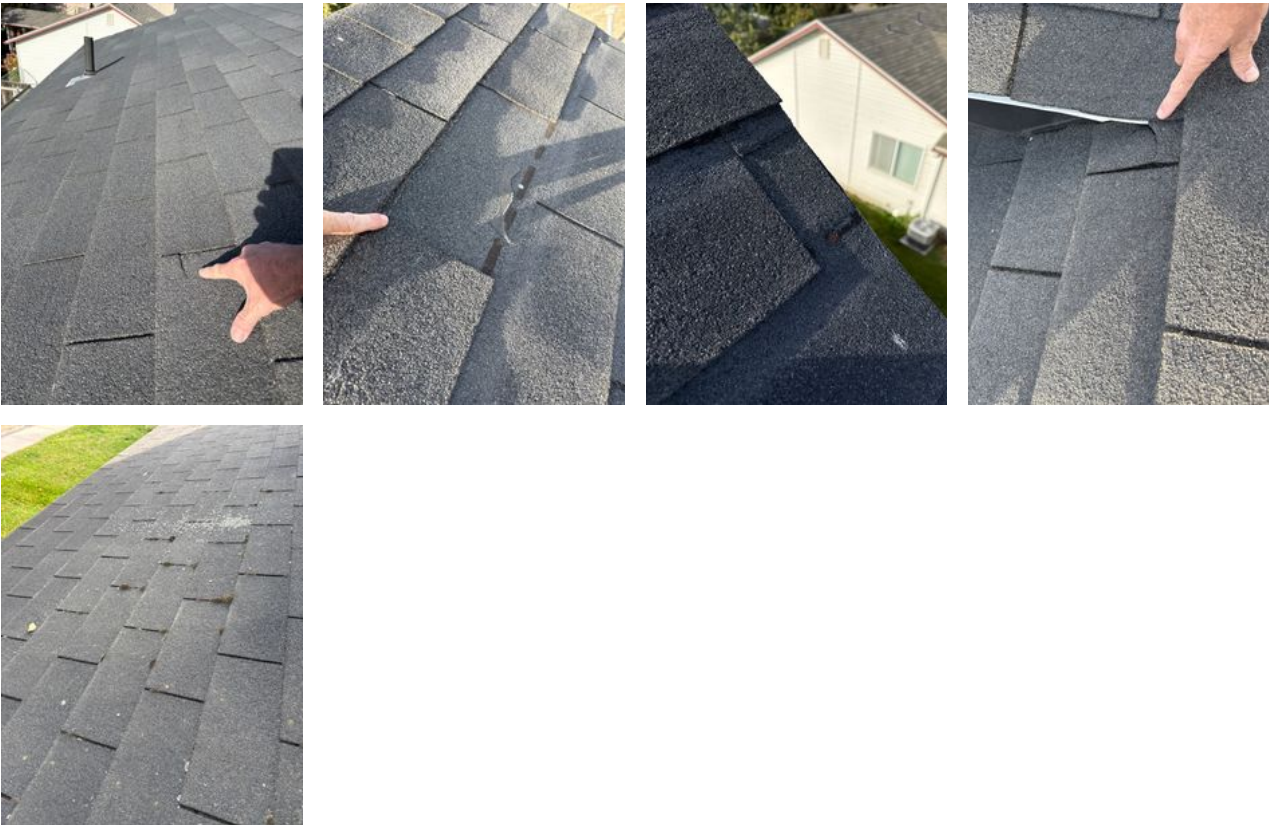
Roofing: Roof Covering

Minor shingle damage observed, as well as a missing shingle tab. These minor repairs will help preserve the roof covering and prevent water penetration. Minor accumulation of organic growth on roof covering over front porch. It is suspected to be from past overgrowth of adjacent tree. It is recommended a roofing contractor make these minor repairs and remove the organic material from the shingles.

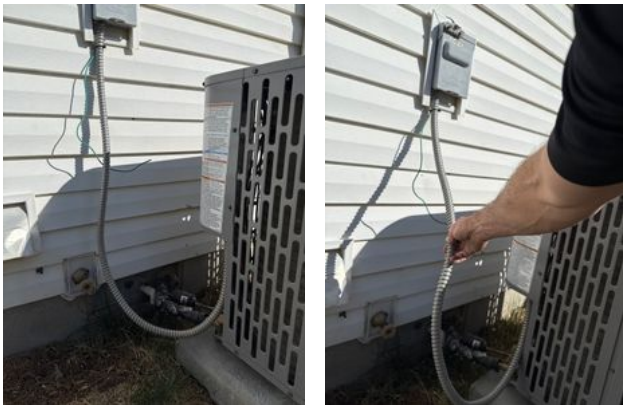
Electrical: Branch Circuit Wiring

Securing the flexible conduit housing the branch circuit wiring, supplying power to the air conditioning condenser is recommended by a qualified contractor.

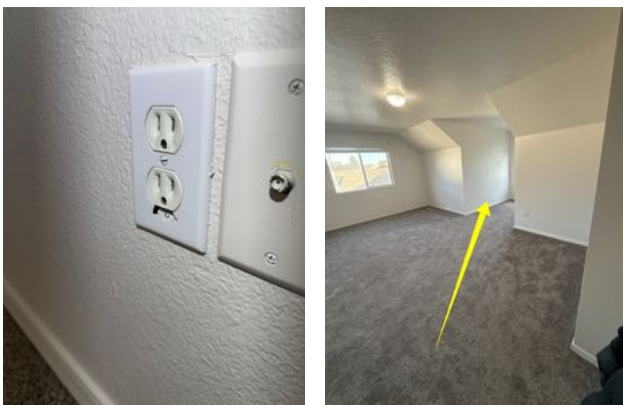
Electrical

Replacing this broken cover plate in the bonus room is recommended.

A loose receptacle was observed in the bonus room. It is recommended a qualified contractor repair these items.

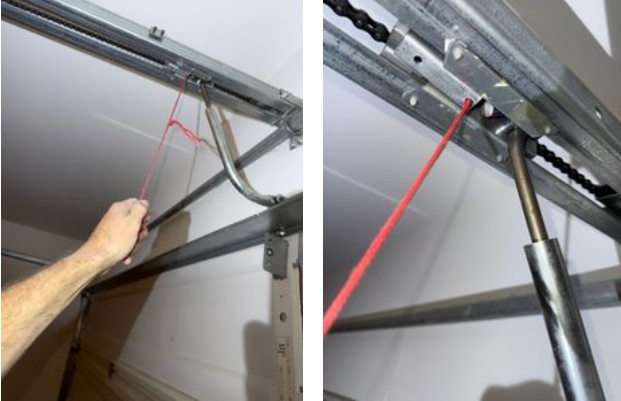
Garage: Opener Safety Feature

The manual disconnect for the overhead vehicle door was inoperable at the time of the inspection. Correction should be made by a qualified garage door contractor.

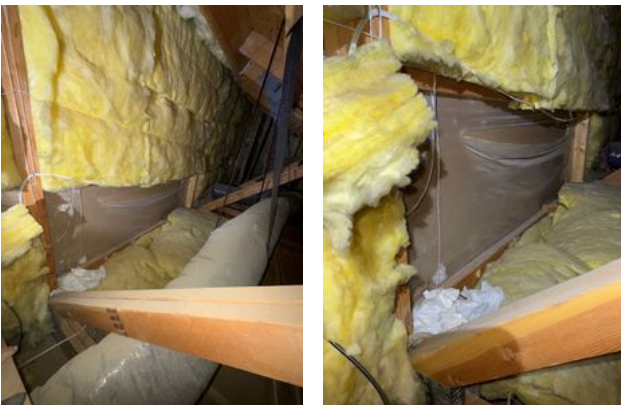
Structure: Attic: Insulation

Fiberglass batt insulation was observed to have been displaced in the attic access from the garage. Reattaching this insulation is recommended.

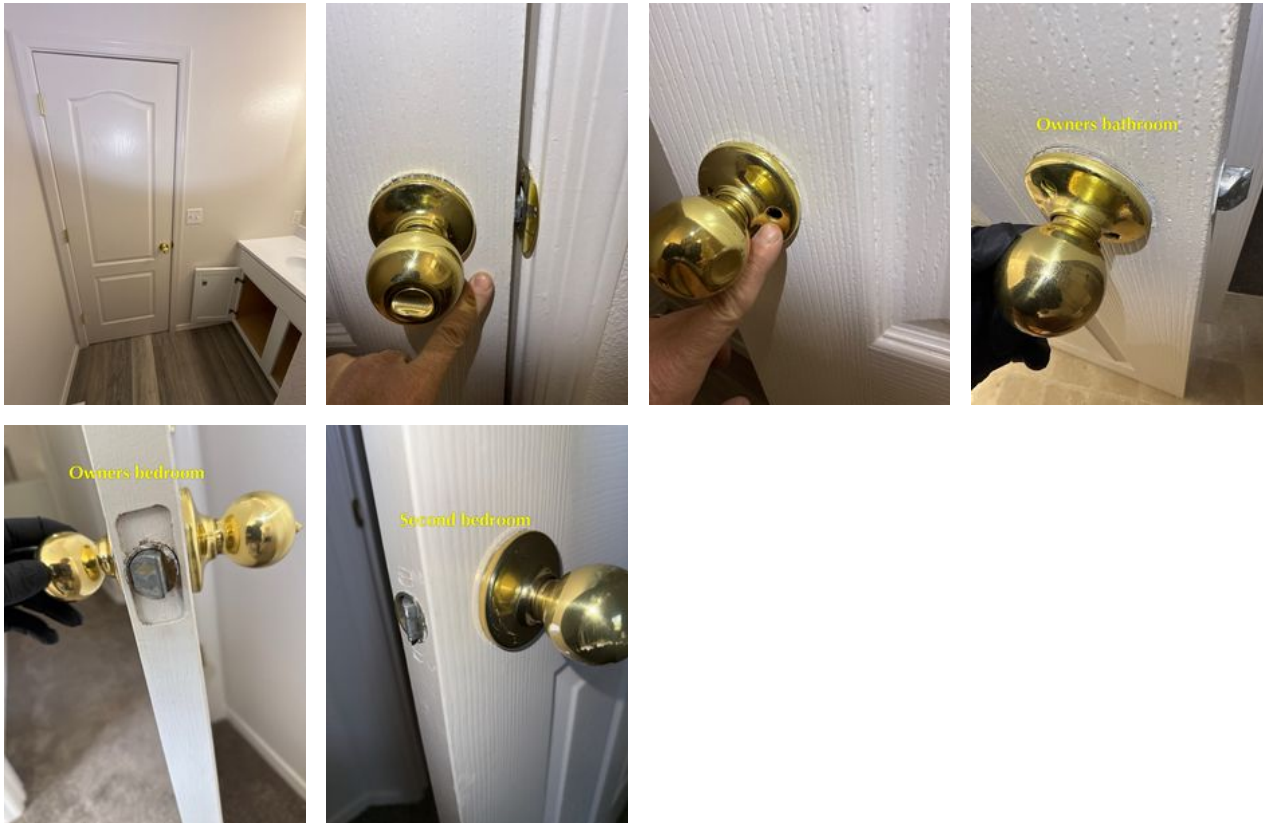
Interior: Interior Door Materials

This bathroom door latch did not lineup with strike plate at the time of inspection. Repairing this and securing the hardware on the identified doors is recommended.

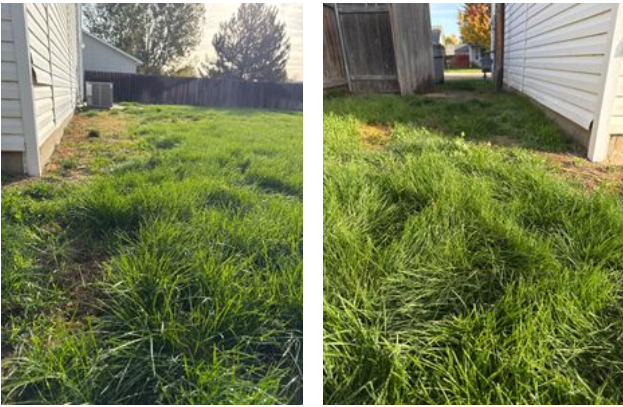
It is recommended to ensure that the grade slopes away from the home. The home had areas of neutral or negative drainage that will route runoff from precipitation toward the foundation. The ground should slope away from the home a minimum of 1/4-inch per foot for a distance of at least six feet from the foundation.

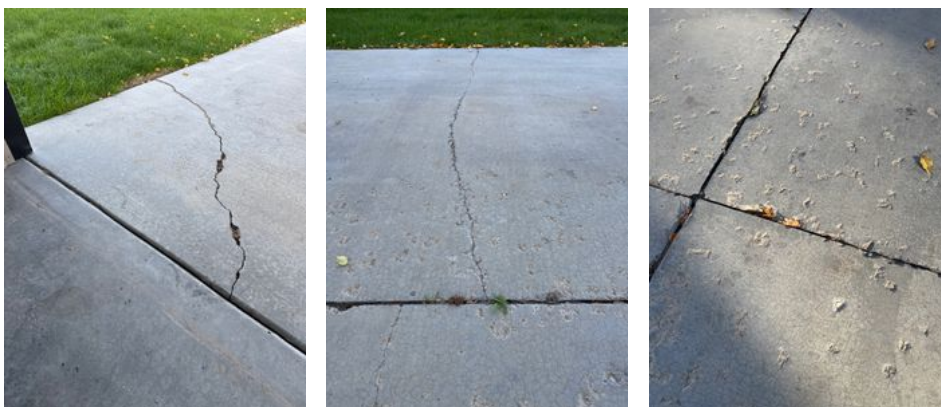
The driveway had areas of pop-out visible. Pop-outs are typically caused by aggregate (stones or gravel) in the concrete that react to moisture by expanding slightly, causing the concrete directly above to detach from the surface. This condition is primarily cosmetic, although in some cases it can lead to further slow deterioration if surface moisture comes into contact with embedded reinforcement steel.

Common cracks were visible in the driveway. Cracks exceeding 1/4 inch should be filled with an appropriate material to avoid continued damage to the driveway surface from freezing moisture.

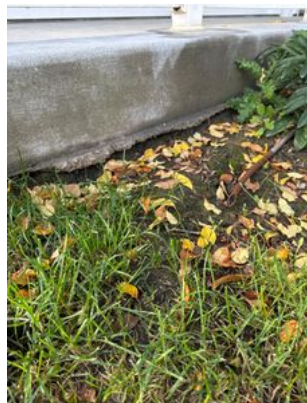
It is recommended to add backfill to support this section of the porch. Backfill is the process of filling in gaps or areas where soil has eroded or settled. By adding backfill, you can improve the stability of the porch, prevent further erosion, and ensure that it remains level and safe for use. This will help protect the porch from potential damage caused by shifting soil.

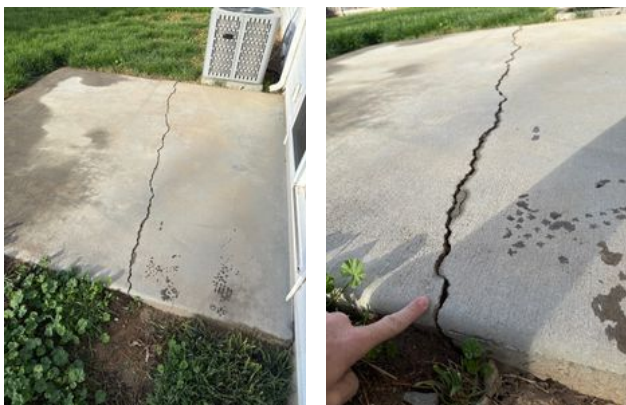
The patio surface had moderate cracking visible. Cracks wider than 1/4-inch should be filled with an appropriate material to help prevent continued deterioration from freezing moisture.

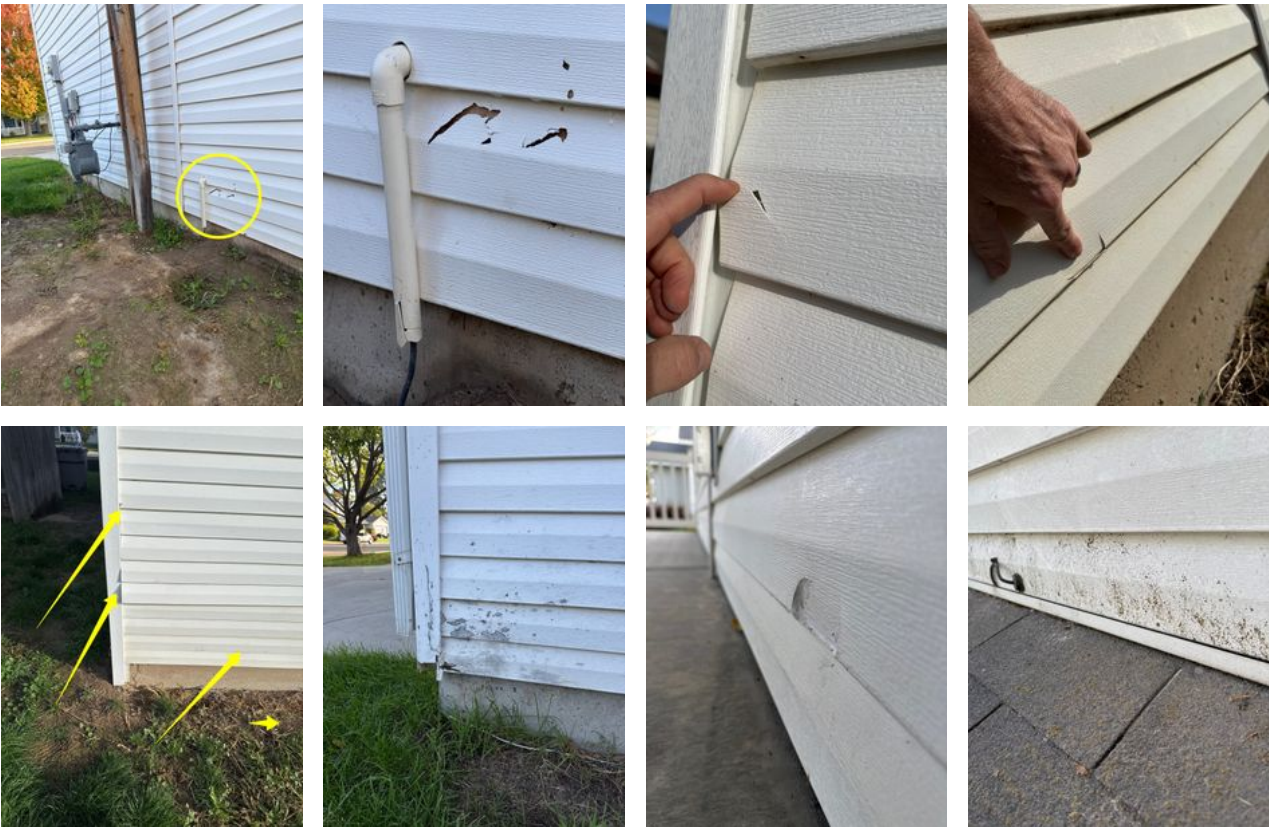
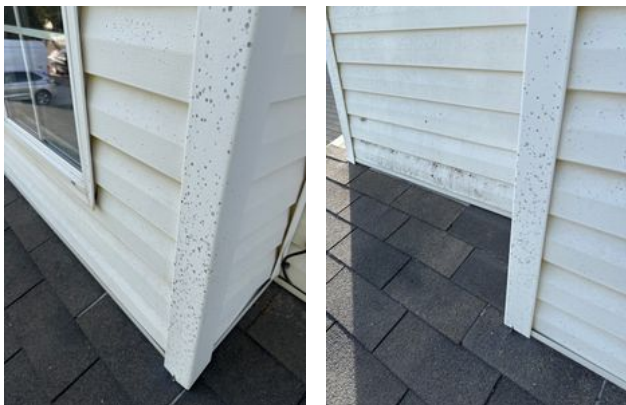
Some areas of the vinyl siding was observed to have cracking damage. Replacement of these damaged areas is preferred to prevent moisture from penetrating the wall sheathing. Many damaged areas were observed to be repaired. Regular maintenance of these repairs is recommended.

Staining on vinyl siding above the front porch is suspected from the past overgrowth of adjacent tree. It is recommended a qualified contractor make the siding repairs and remove the organic material from the siding at the front of the house.

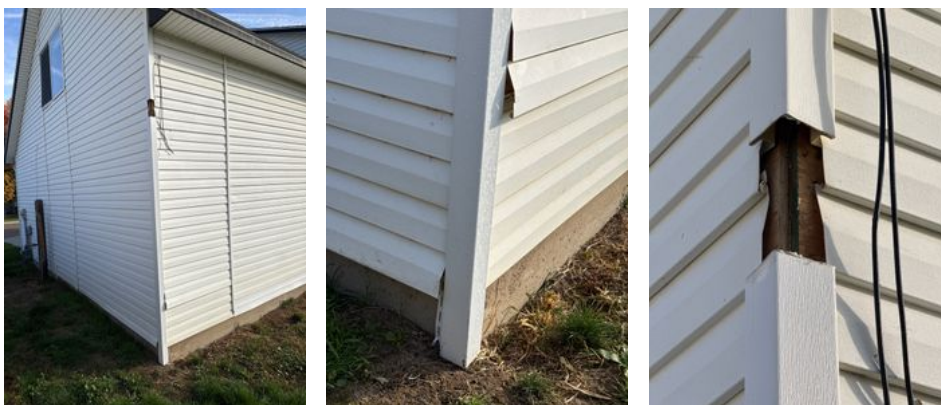
This vinyl trim piece has disconnected from the attachment point and has exposed the exterior sheathing. Replacement of this trim piece is required to protect the homes building material from damage.

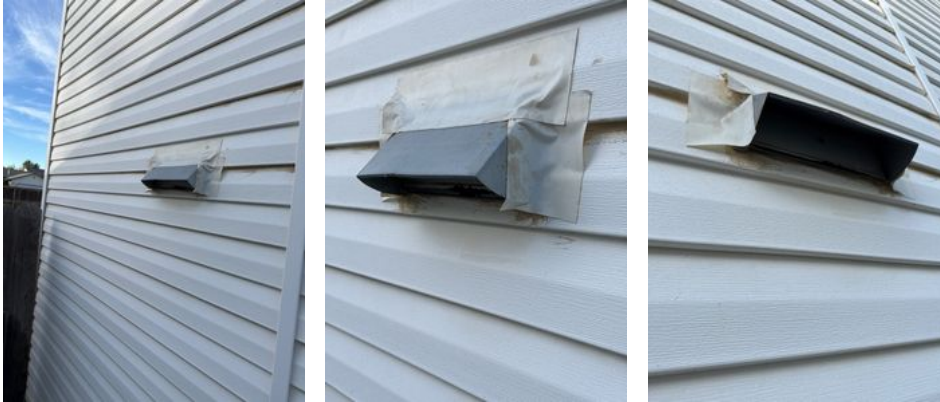
The appropriate trim was not installed around this exhaust vent discharge. All exterior wall penetrations require the appropriate flashing and trim pieces to prevent moisture intrusion. Replacement is recommended.

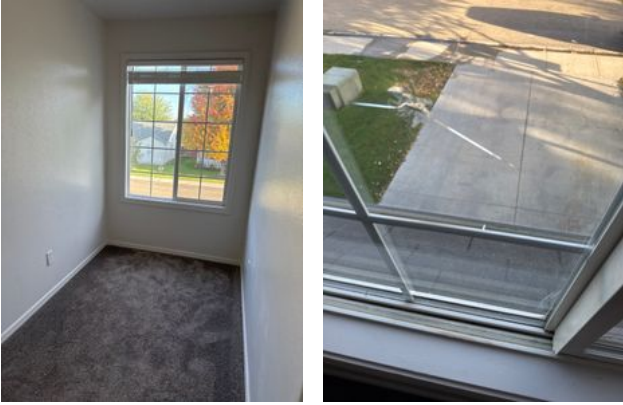
A window on the north side of the home in the bonus room was observed to have a broken pane. Replacing this window is recommended.

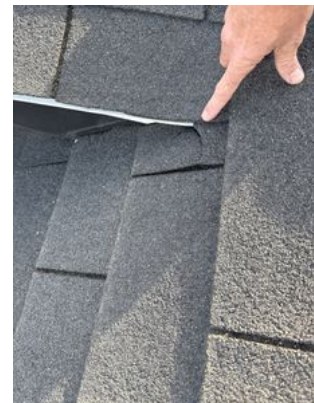
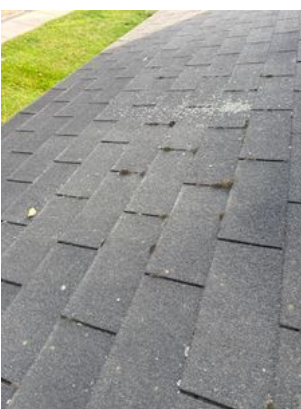
Minor shingle damage observed, as well as a missing shingle tab. These minor repairs will help preserve the roof covering and prevent water penetration. Minor accumulation of organic growth on roof covering over front porch. It is suspected to be from past overgrowth of adjacent tree. It is recommended a roofing contractor make these minor repairs and remove the organic material from the shingles.

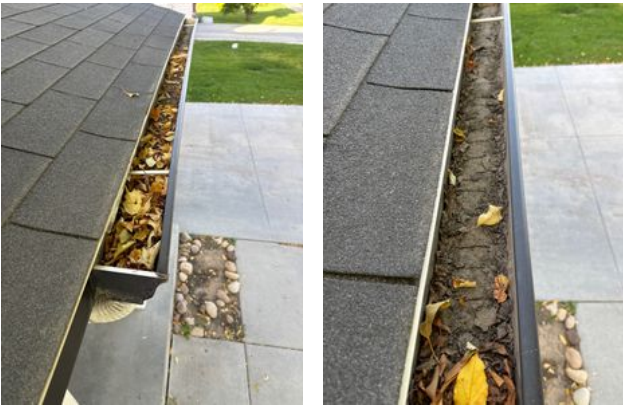
This gutter over the front entryway was filled with sediment, indicating a lack of proper gutter drainage. Repairing this condition will help shed the water from the roof and away from the foundation.

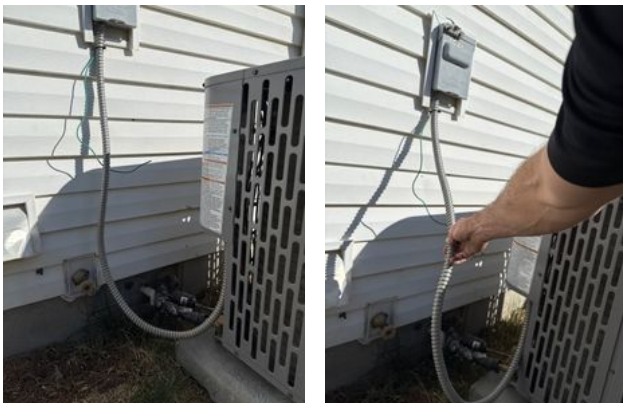
Securing the flexible conduit housing the branch circuit wiring, supplying power to the air conditioning condenser is recommended by a qualified contractor.

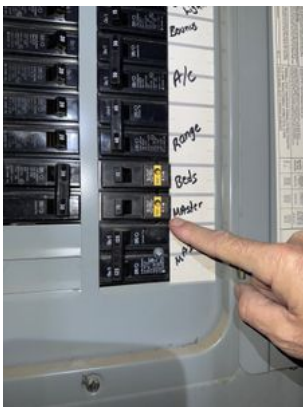
This bedroom had an arc-fault circuit interrupter (AFCI) receptacle that did not respond to testing. The Inspector recommends service by a qualified contractor.

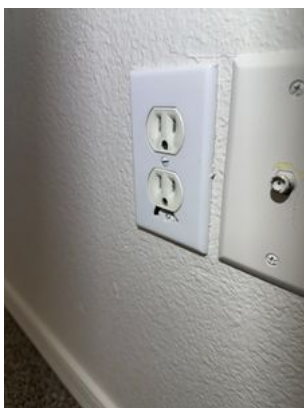
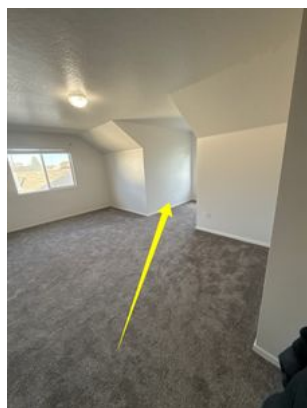
Replacing this broken cover plate in the bonus room is recommended.

A loose receptacle was observed in the bonus room. It is recommended a qualified contractor repair these items.

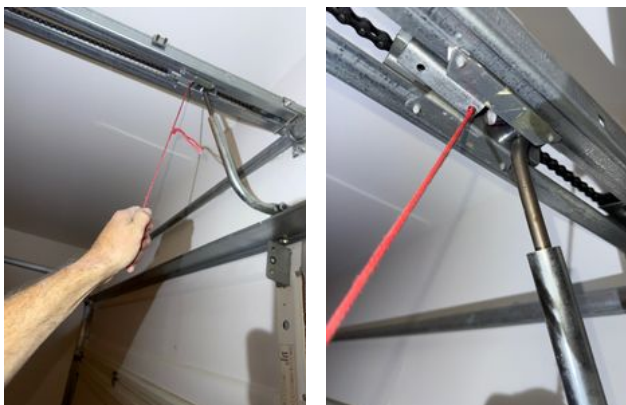
The manual disconnect for the overhead vehicle door was inoperable at the time of the inspection. Correction should be made by a qualified garage door contractor.

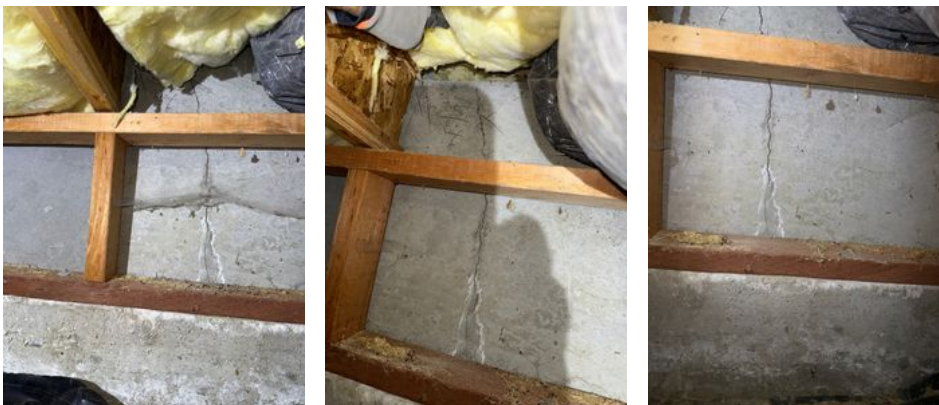
Typical shrinkage crack visible in the foundation are not a structural concern. Shrinkage is a natural part of the curing process of concrete and surface cracking is common.

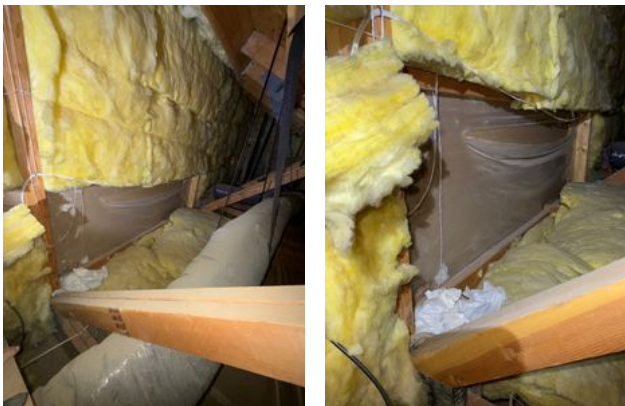
Fiberglass batt insulation was observed to have been displaced in the attic access from the garage. Reattaching this insulation is recommended.

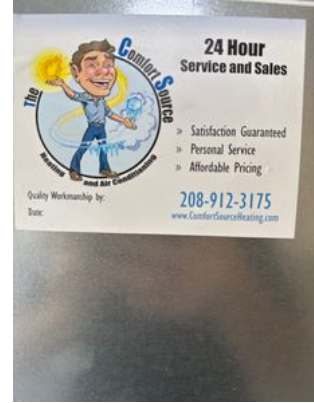
The access door was not removable at the time of inspection. It is recommended to follow up with the installer to inquire about servicing the furnace filter.

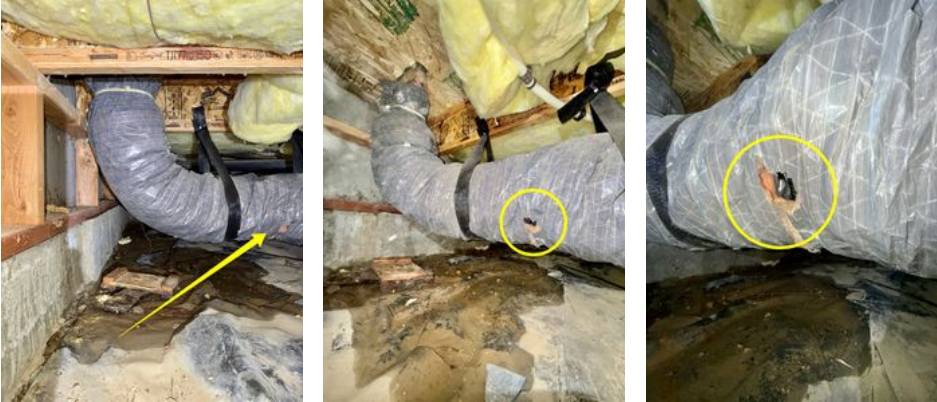
A flexible supply duct in the crawlspace appeared to have damage from mice. This will dispense the conditioned air into the crawlspace. It is recommended to acquire an estimate from a qualified HVAC contractor for replacement.

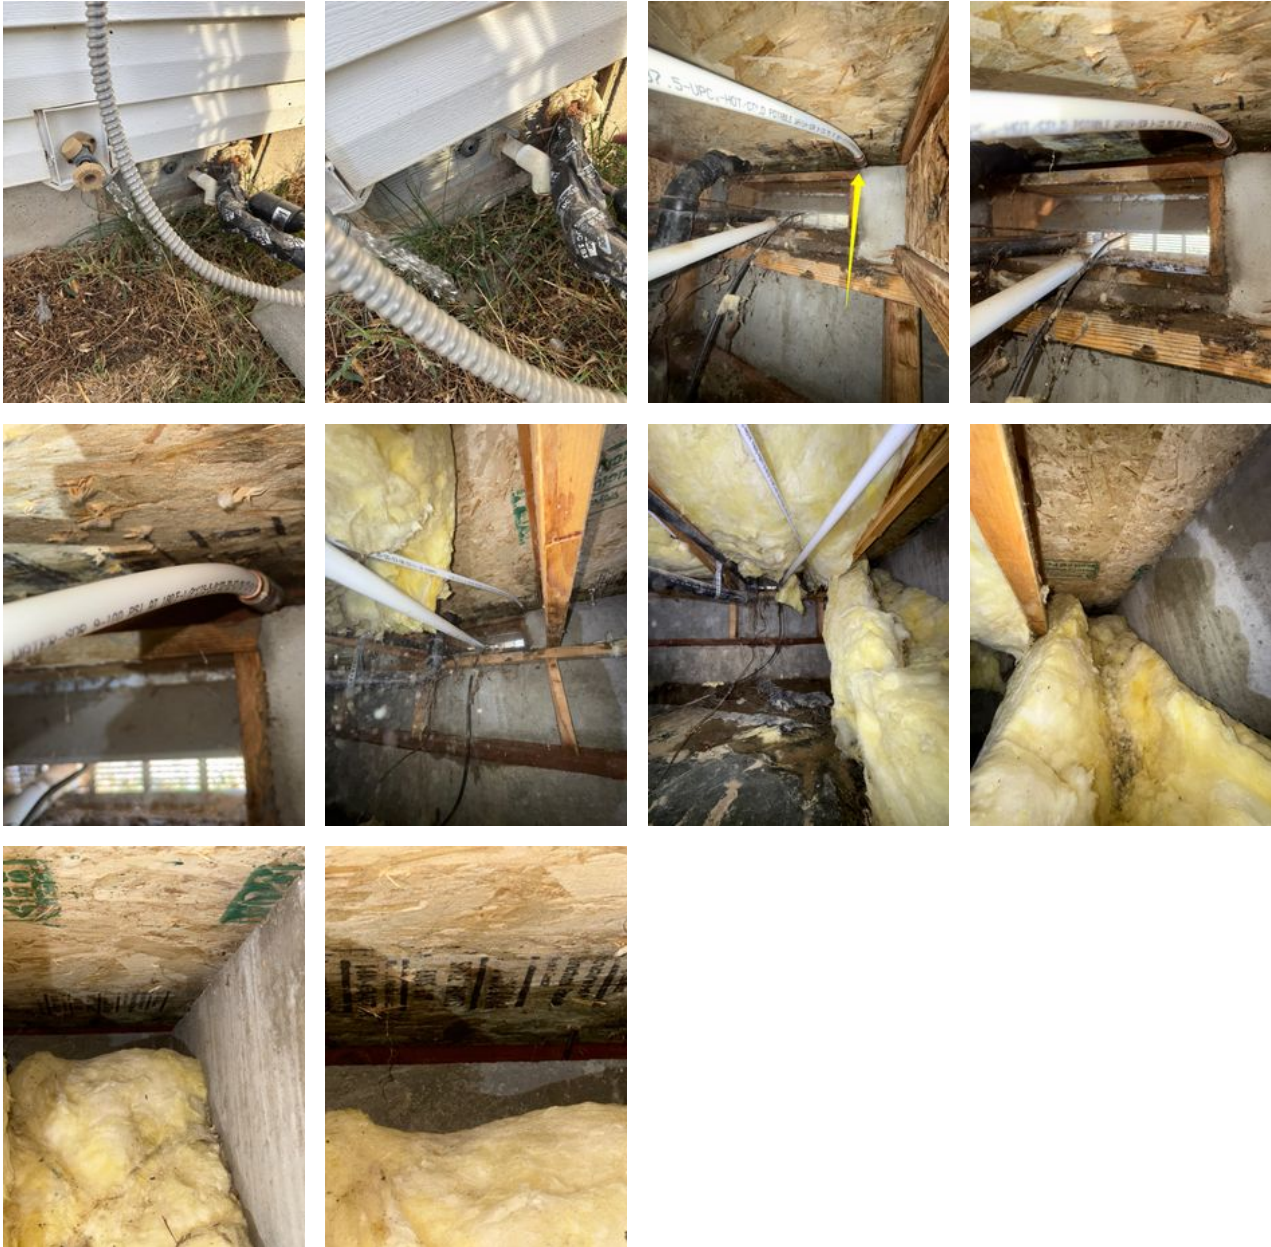
When the hose bibb near the rear door was operated, the water dispensed as intended and was leaking out of the adjacent crawl space vent. The valve was immediately turned off to prevent further water damage. Upon inspecting the crawl space,

the leak was confirmed with moisture on the vapor barrier, the insulation and the adjacent building material. This appears to be a relatively recent developed condition. Repairing this water line is required before using this hose bibb and it is recommended to ensure all necessary materials are in acceptable condition prior to closing.

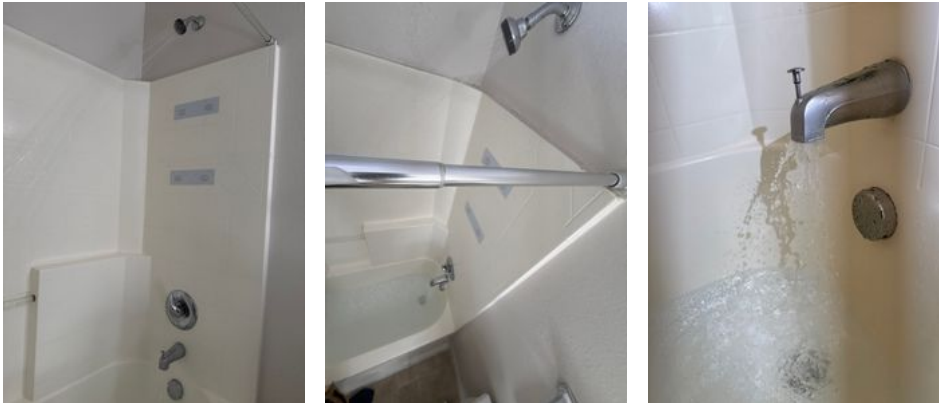
The diverter valve did not operate correctly (the diverter is the valve that diverts water from the tub faucet to the shower head). Water was diverted to shower head but continued to flow from tub faucet. The Inspector recommends maintenance be performed by a qualified contractor.

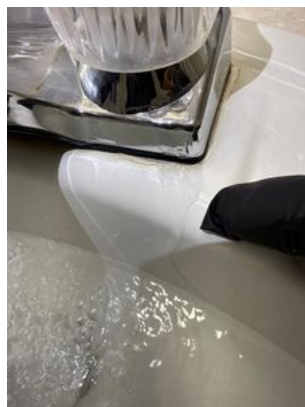
Water was flowing out of the handle on the cold water side in this sink faucet. Repairing this is or replacing faucet is recommended.

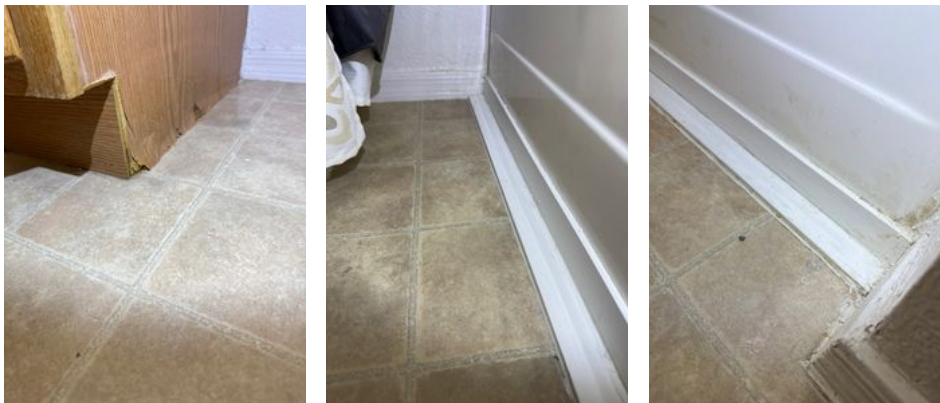
Signs of past presence of moisture on this bathroom floor is evidence by swollen cabinet and installation of additional trim around the bathtub. No current moisture was observed on moisture meter at time of inspection.

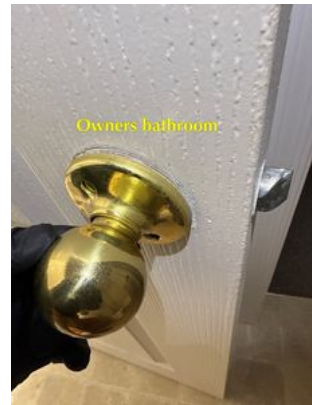
This bathroom door latch did not lineup with strike plate at the time of inspection. Repairing this and securing the hardware on the identified doors is recommended.
