Home Inspection Report

Kuna, ID 83634

Inspected On Tue, Oct 4, 2022 at 1:00 PM

Upright Home Inspection
(208) 241-9059
UprightInspections.com

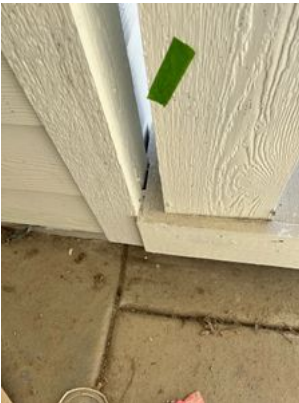
Many areas taped to identify their need to sealed and prepped for final weatherproof painting.

One board near entrance observed to have a chip in it. Replacement recommended.

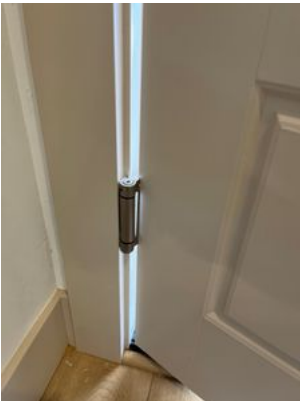
The self-closing hinges on the conventional door between the garage and the home living space did not function at the time of inspection. Self-closing hinges are a safety feature designed to help prevent the spread of fire and toxic fumes from the garage to the living space. Correction recommended.

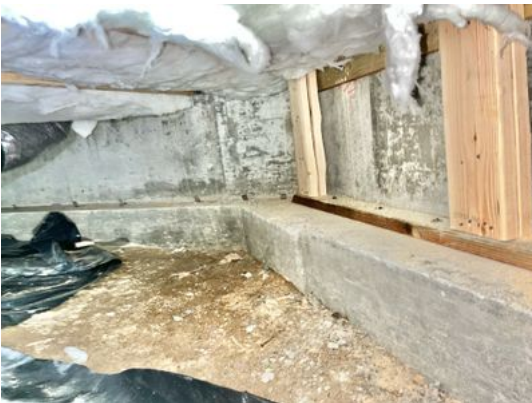
The floor of the crawlspace was covered with a vapor barrier cover that consisted of sheet plastic. Soil covers are installed to help minimize moisture evaporation into crawlspace air from the soil. Edges at overlaps and the crawlspace perimeter were not sealed. It is recommended to repair this condition and replace barrier as needed.

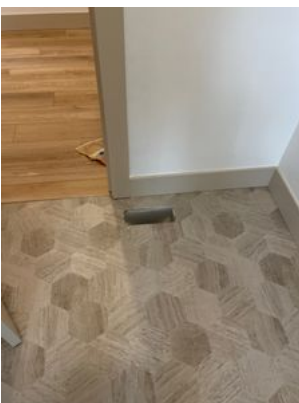
Air flow was minimal in laundry room. Further evaluation recommended by a qualified HVAC contractor.

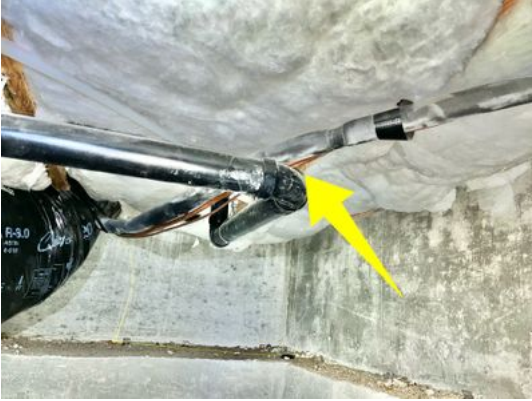
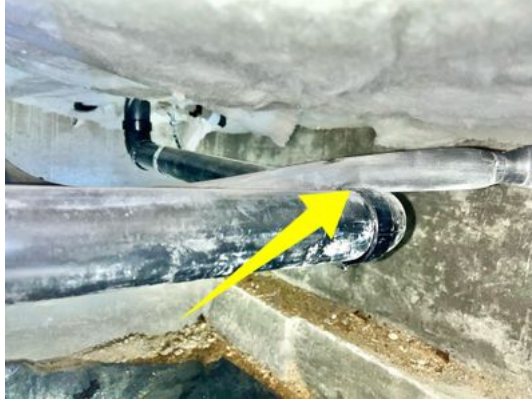
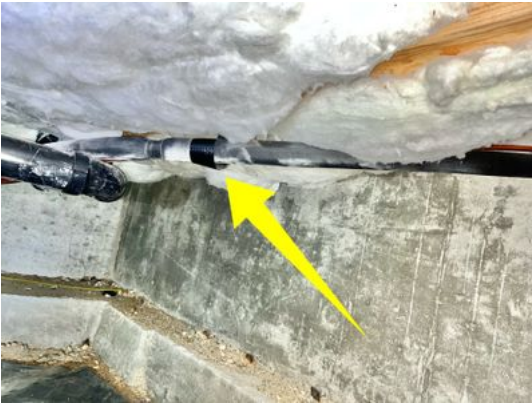
The A/C line set was resting upon a waste or drain pipe at the time of inspection. This condition may damage the pipe or loosen the connections. The inspector recommends correction by a qualified plumbing contractor.

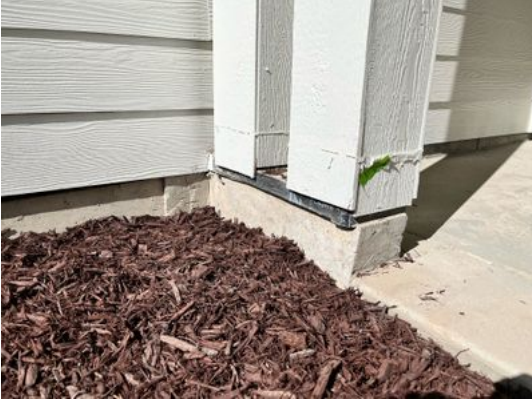
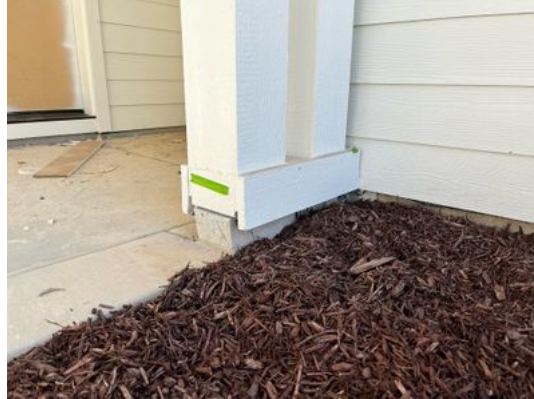
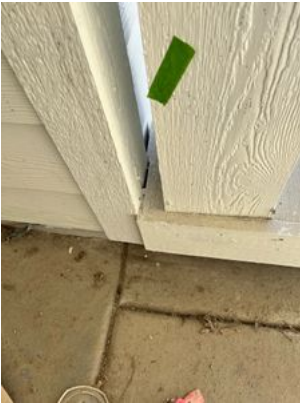
Comment 1

Trim finishing, sealing joints and painting recommended throughout exterior and including posts at entrance stoop.

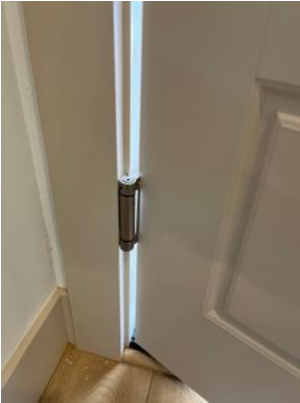
Comment 6

The self-closing hinges on the conventional door between the garage and the home living space did not function at the time of inspection. Self-closing hinges are a safety feature designed to help prevent the spread of fire and toxic fumes from the garage to the living space. Correction recommended.

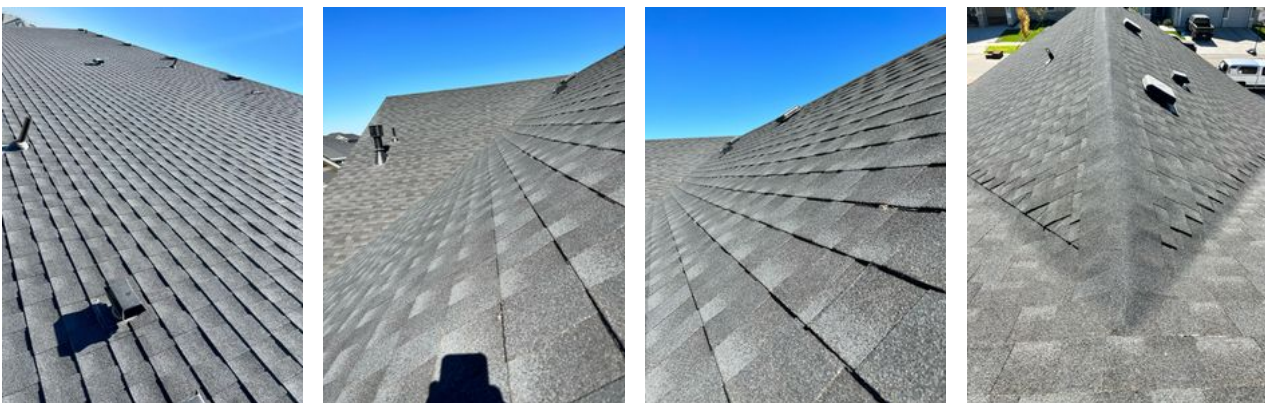
**Comment 8
Information**

Two fall protection anchors were not covered at time of inspection. Replacing the plastic covers is recommended.

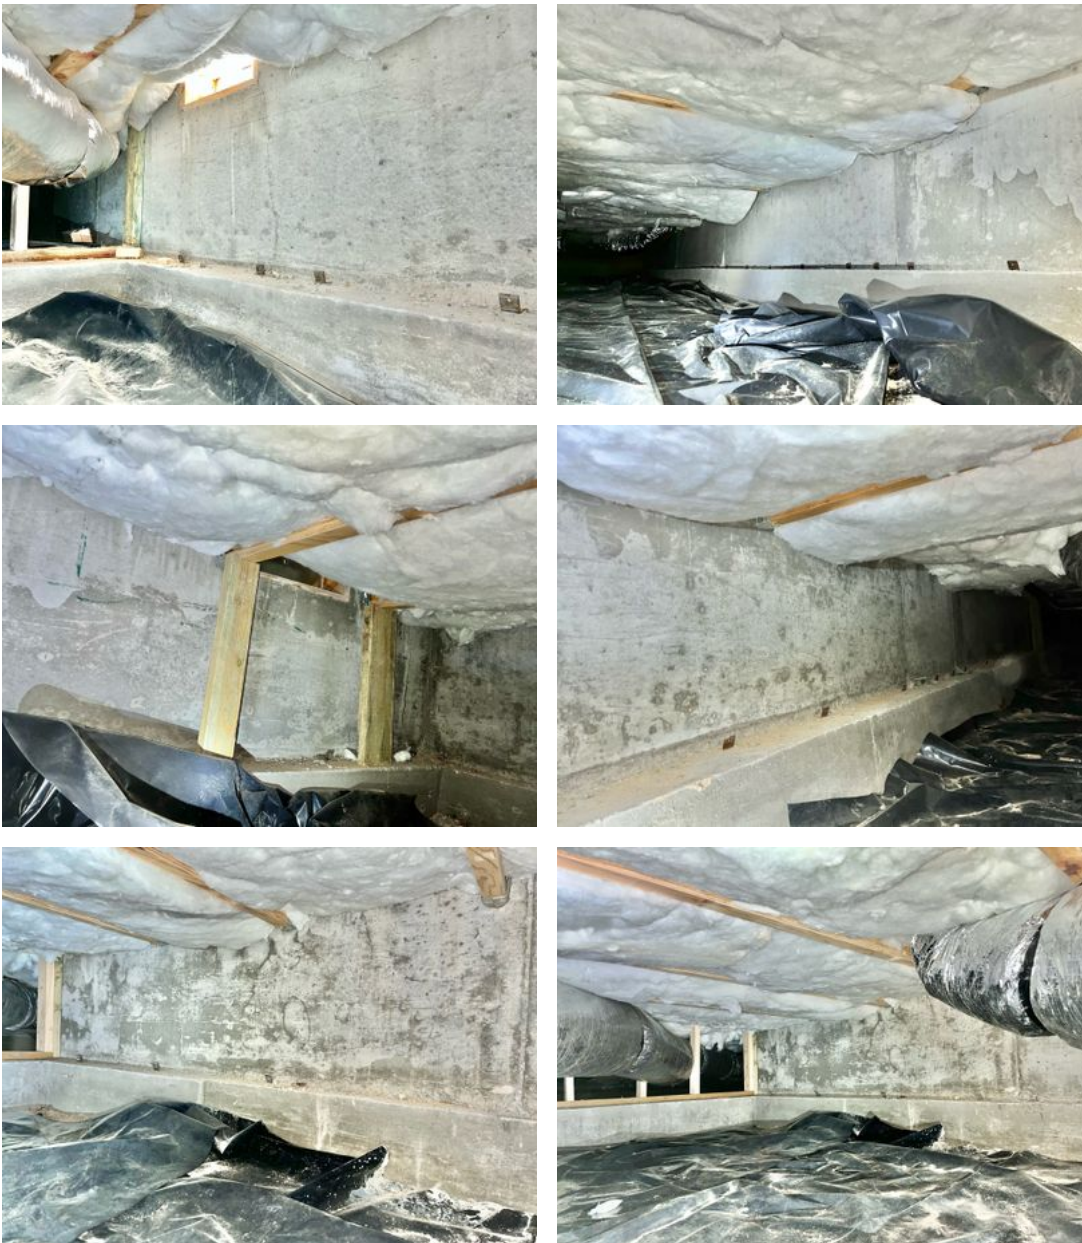
Cracking visible at the foundation wall appeared typical of differential settlement. Differential settlement happens when one portion of the foundation settles at a rate different from adjacent portions of the foundation. Stresses are

created at the point of changing support that are relieved by cracking. Settlement typically takes place in the first few years after original construction, and then stops. Cracks exceeding 1/16-inch in width should be filled with an appropriate material to prevent future damage from freezing moisture and monitored in the future for continued activity. A qualified foundation contractor is recommended to evaluate and seal these cracks.

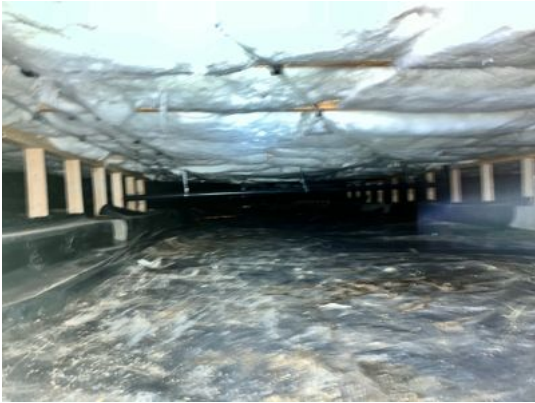
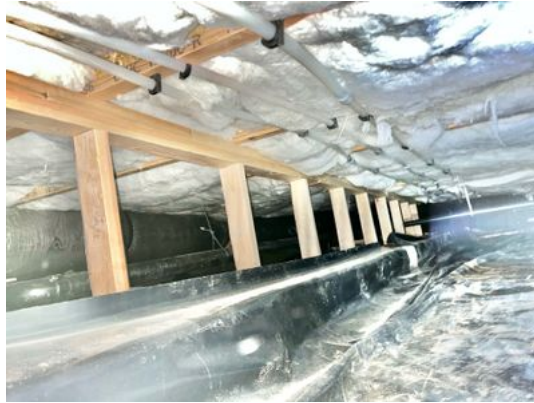
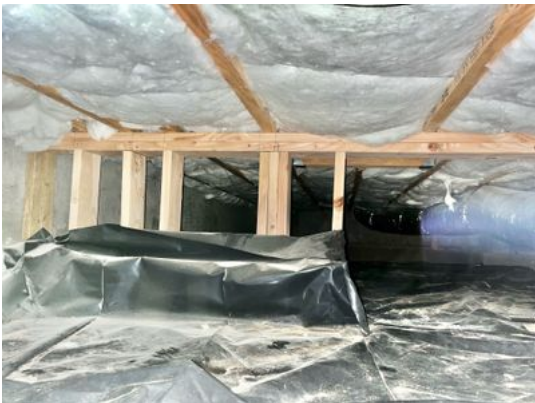
The floor of the crawlspace was covered with a vapor barrier cover that consisted of sheet plastic. Soil covers are installed to help minimize moisture evaporation into crawlspace air from the soil. Edges at overlaps and the crawlspace perimeter were not sealed. It is recommended to repair this condition and replace barrier as needed.

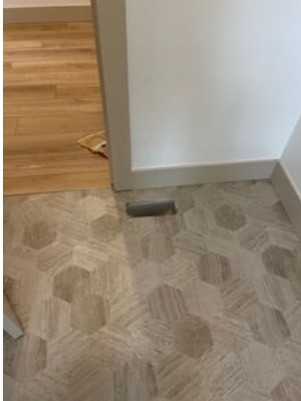
Air flow was minimal in laundry room. Further evaluation recommended by a qualified HVAC contractor.

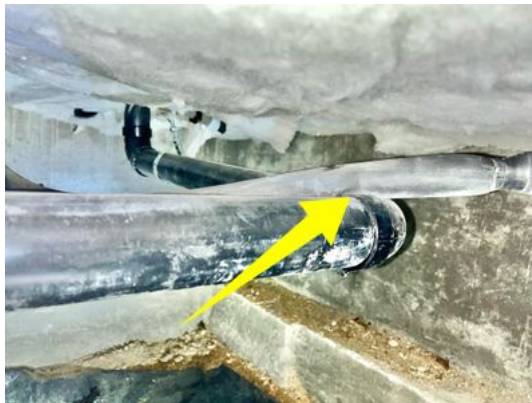
The A/C line set was resting upon a waste or drain pipe at the time of inspection. This condition may damage the pipe or loosen the connections. The inspector recommends correction by a qualified plumbing contractor.

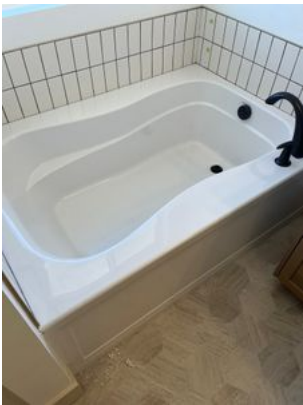
Cleaning install sticker recommended.

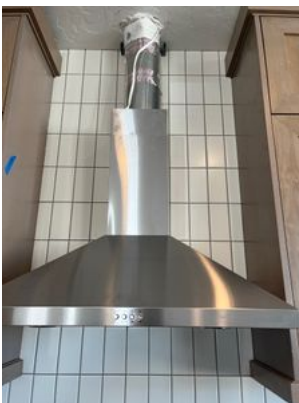
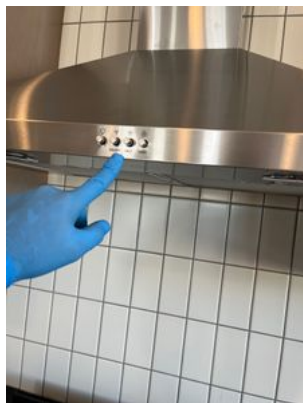
Range Hood

Condition: Repair or Replace

No power to unit at time of inspection

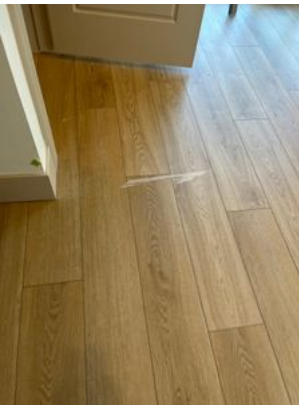
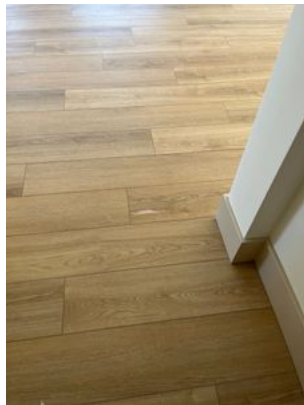
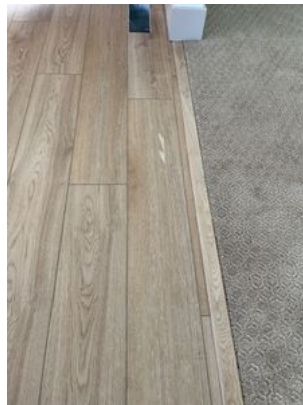
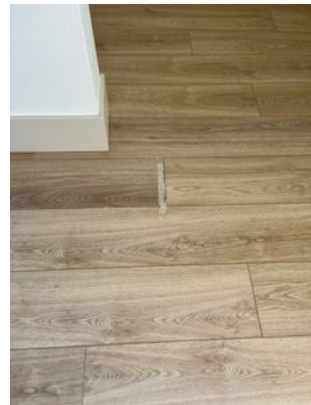
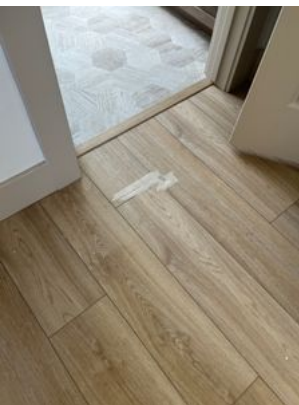
Floors

Tape on floor observed at time of inspection. Removal needed.

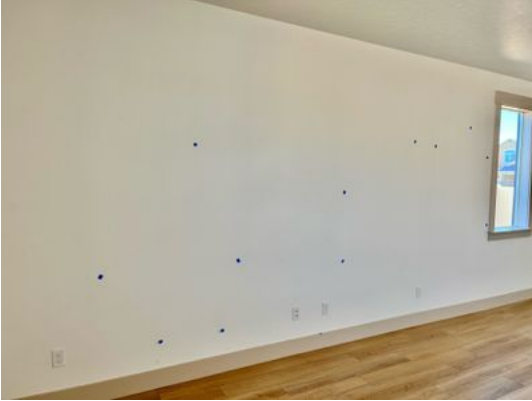
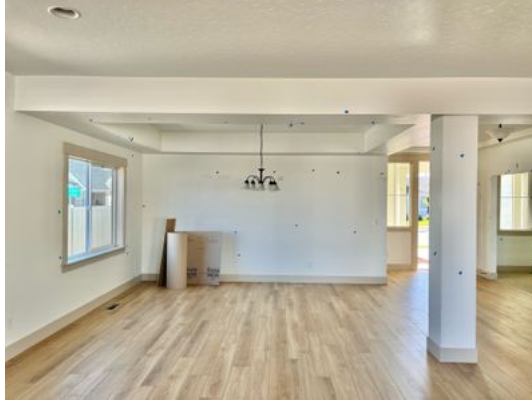
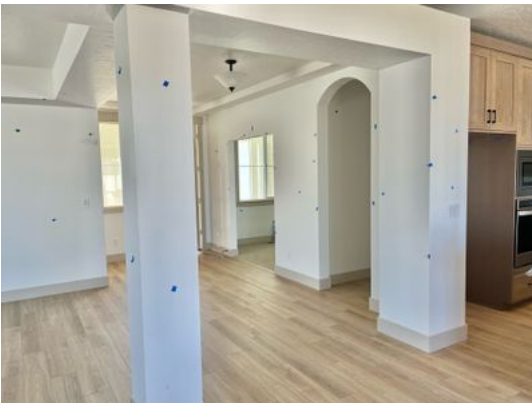
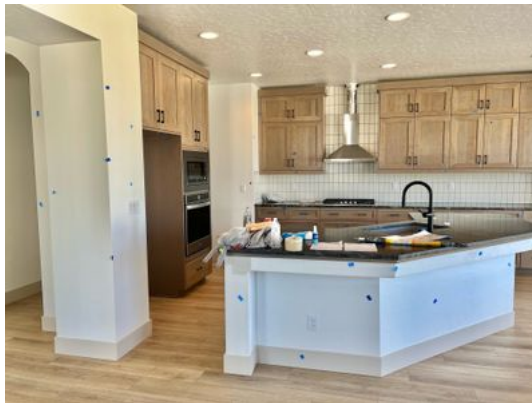
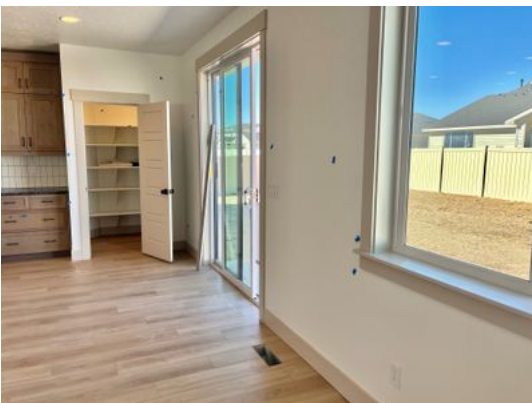
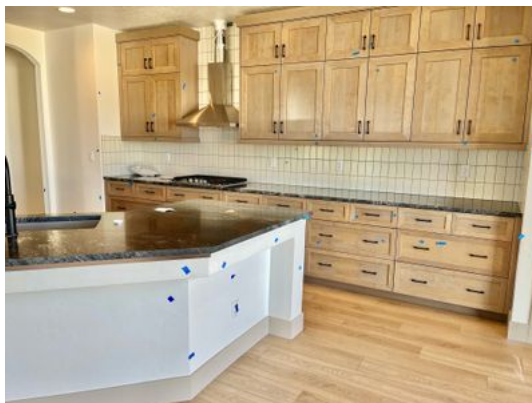
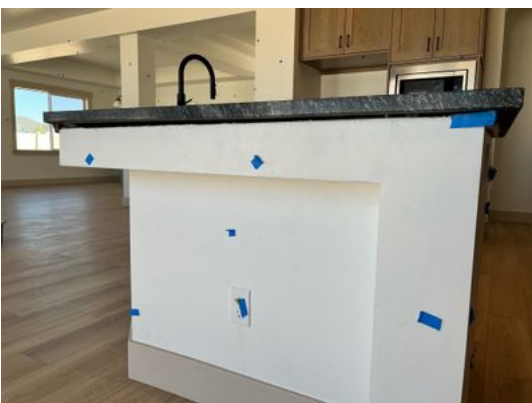
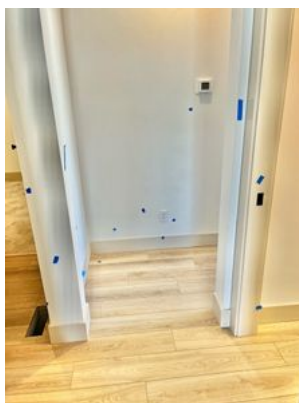
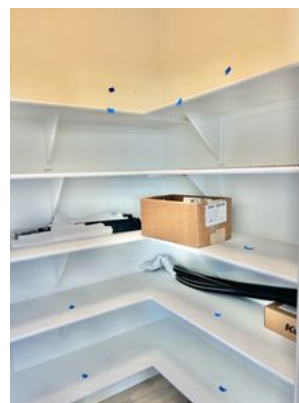
Walls

Marks for correction are throughout the home to have contractors follow up with.

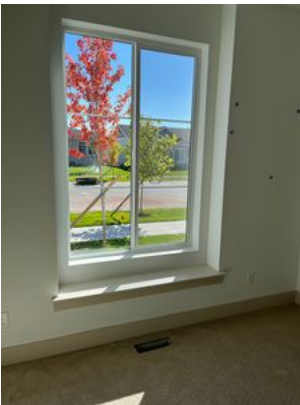
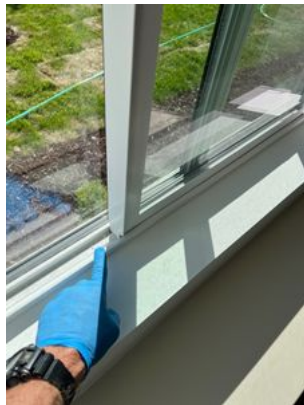
Window Types

Correction needed for sliding window.ON SITE REPAIRED PRIOR TO END OF INSPECTION

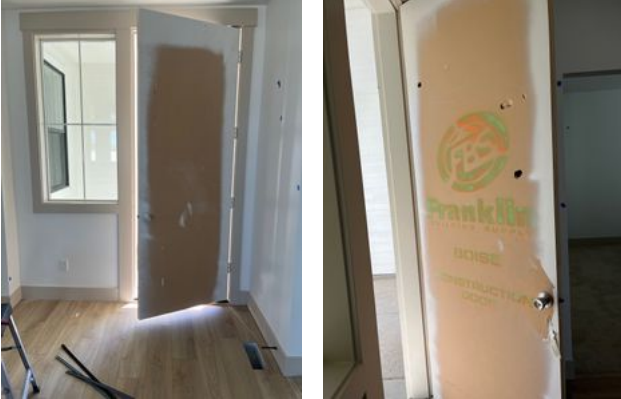
Temporary door installed at entrance.
