Home Inspection Report

123 Fakesbille

Inspected By: Scott Frasure

Inspected On Thu, Oct 3, 2024 at 9:00 AM

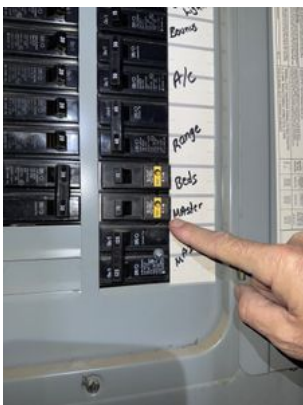
This bedroom had an arc-fault circuit interrupter (AFCI) receptacle that did not respond to testing. The Inspector recommends service by a qualified contractor.

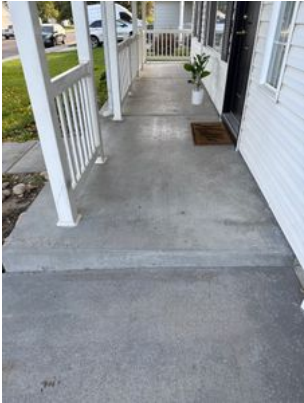
**Comment 3
Recommended**

It is recommended to add backfill to support this section of the porch. Backfill is the process of filling in gaps or areas where soil has eroded or settled. By adding backfill, you can improve the stability of the porch, prevent further erosion, and ensure that it remains level and safe for use. This will help protect the porch from potential damage caused by shifting soil.

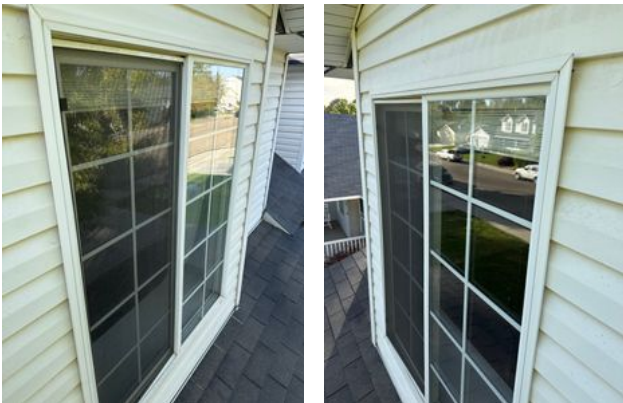
Comment 9
Minor/Repair

A window on the north side of the home in the bonus room was observed to have a broken pane. Replacing this window is recommended.

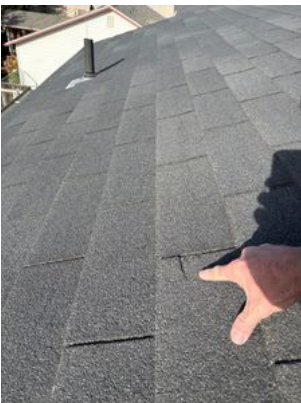
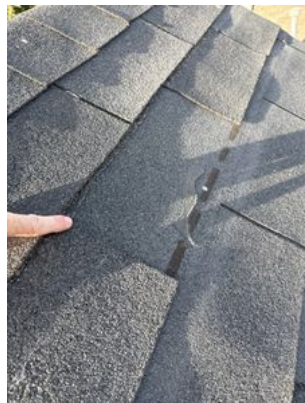
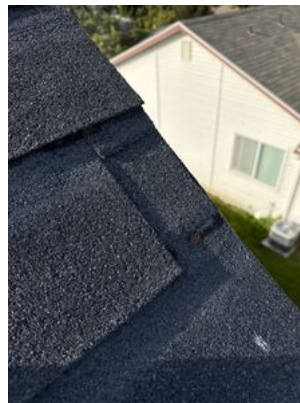
Minor shingle damage observed, as well as a missing shingle tab. These minor repairs will help preserve the roof covering and prevent water penetration. Minor accumulation of organic growth on roof covering over front porch. It is suspected to be from past overgrowth of adjacent tree. It is recommended a roofing contractor make these minor repairs and remove the organic material from the shingles.

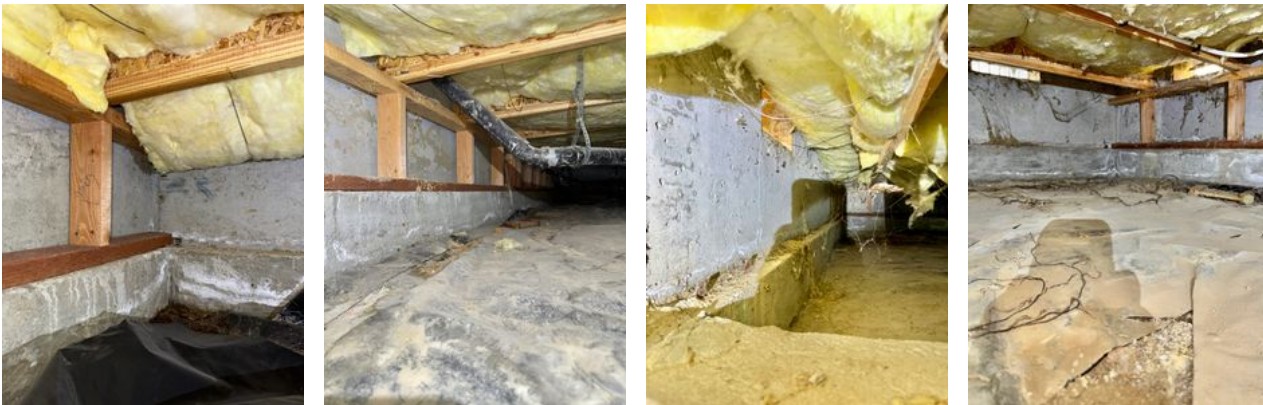
Comment 17
Informational

Typical shrinkage crack visible in the foundation are not a structural concern. Shrinkage is a natural part of the curing process of concrete and surface cracking is common.

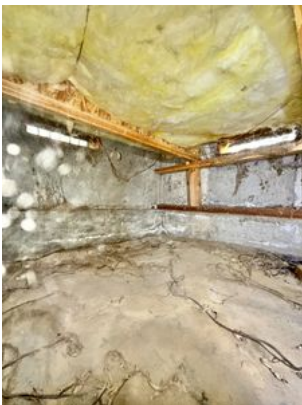
Comment 19
Informational

Some of the homes crawlspace vents were closed at the time of the inspection. Good practice to prevent high humidity levels in the crawlspace is to open these in the summertime and close them in the winter time.

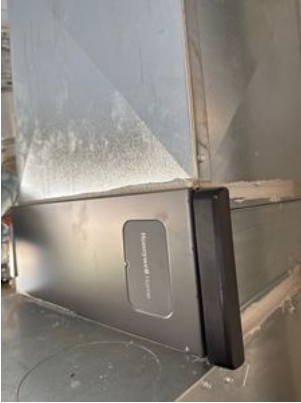
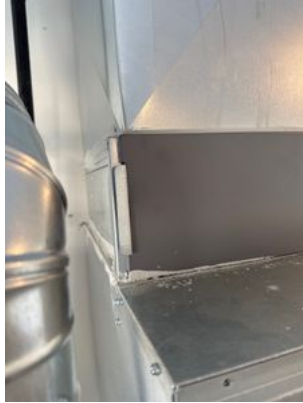
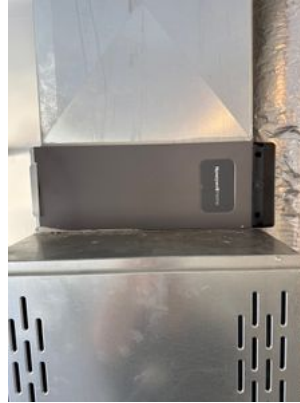
**Comment 20
Informational**

The access door was not removable at the time of inspection. It is recommended to follow up with the installer to inquire about servicing the furnace filter.

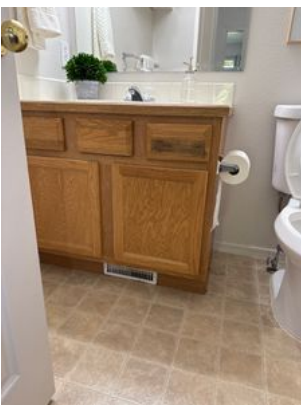
**Comment 21
Minor/Repair**

The register in this upstairs full bathroom was blocked at the time of inspection. Repairing this condition is recommended to help regulate the temperature in this bathroom.

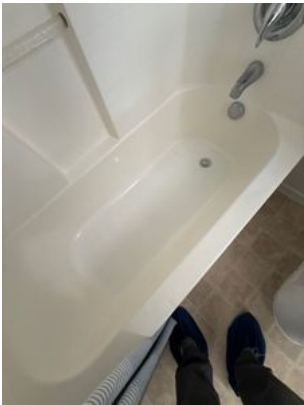
Shower

Condition: Repair or Replace

The diverter valve did not operate correctly (the diverter is the valve that diverts water from the tub faucet to the shower head). Water was diverted to shower head but continued to flow from tub faucet. The Inspector recommends maintenance be performed by a qualified contractor.

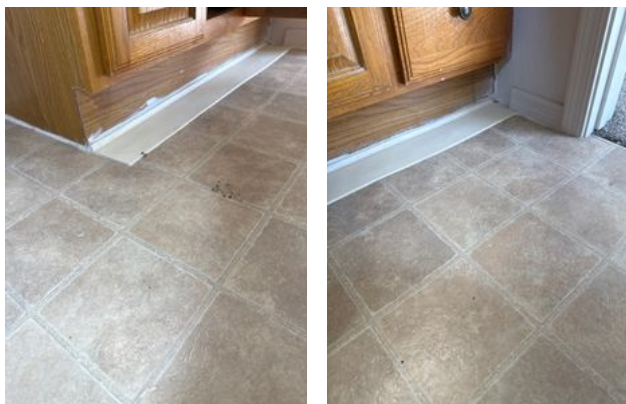
Vinyl

Condition: Marginal

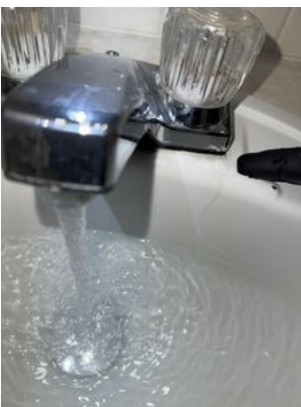
Condition: Repair or Replace

Water was flowing out of the handle on the cold water side in this sink faucet. Repairing this is or replacing faucet is recommended.

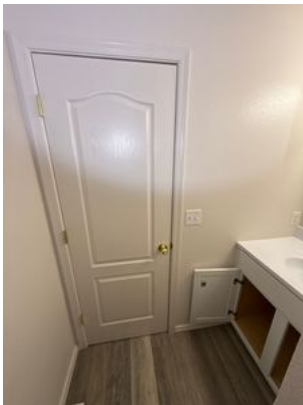
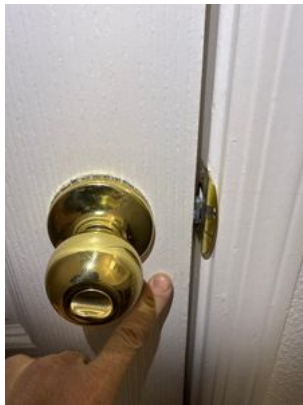
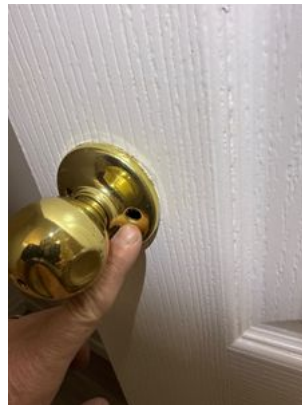
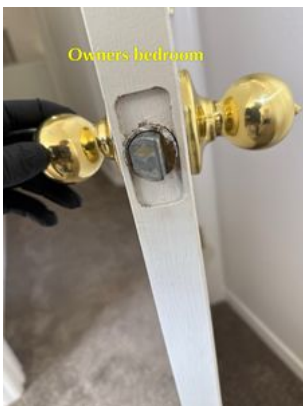
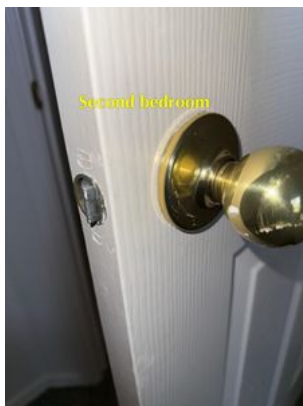
This bathroom door latch did not lineup with strike plate at the time of inspection. Repairing this and securing the hardware on the identified doors is recommended.
